AGENDA ADDENDUM

REGULAR MEETING OF COUNCIL

9.8.1. Remedial Action Requirements – 1576 and 1582 Merlynn Crescent

This document reports on the results of the geotechnical assessment carried out at the West Hastings Escarpment in North Vancouver and provides geotechnical comments and recommendations regarding slope stability. The scope of this assessment included a general site reconnaissance, subsequent detailed site investigation at three areas of concern, slope stability analyses of these selected areas, and preliminary runout analyses and risk assessment. This report is prepared in conformance with our proposed scope of services, dated May 4, 2012. Authorization to proceed was received on May 11, 2012. Subsequently, the scope of services was increased to include more detailed runout analyses and risk assessment for selected properties located at the toe of the subject slope.

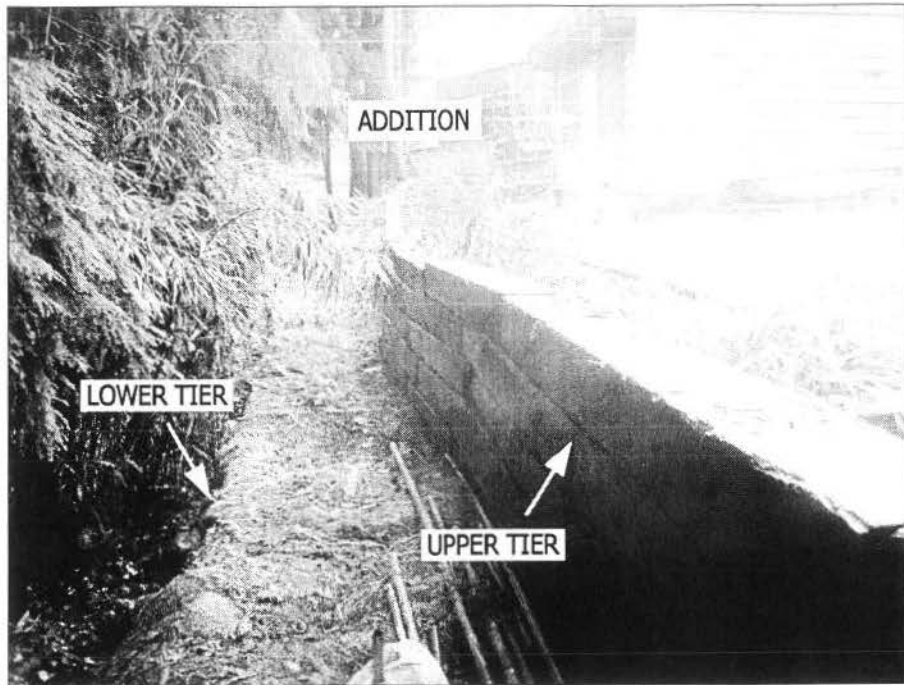
PHOTOGRAPH 1. BULGING TIMBER RETAINING WALL OBSERVED AT 1576 MERLYNN CRESCENT.

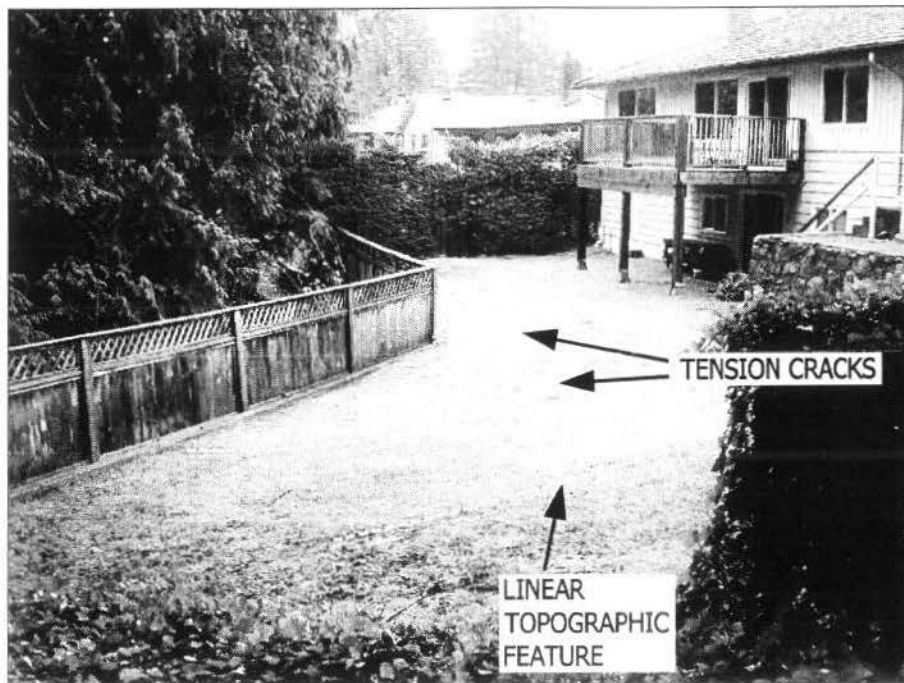
PHOTOGRAPH 2. LINEAR TOPOGRAPHIC FEATURE AND TENSION CRACKS OBSERVED AT 1582 MERLYNN CRESCENT.

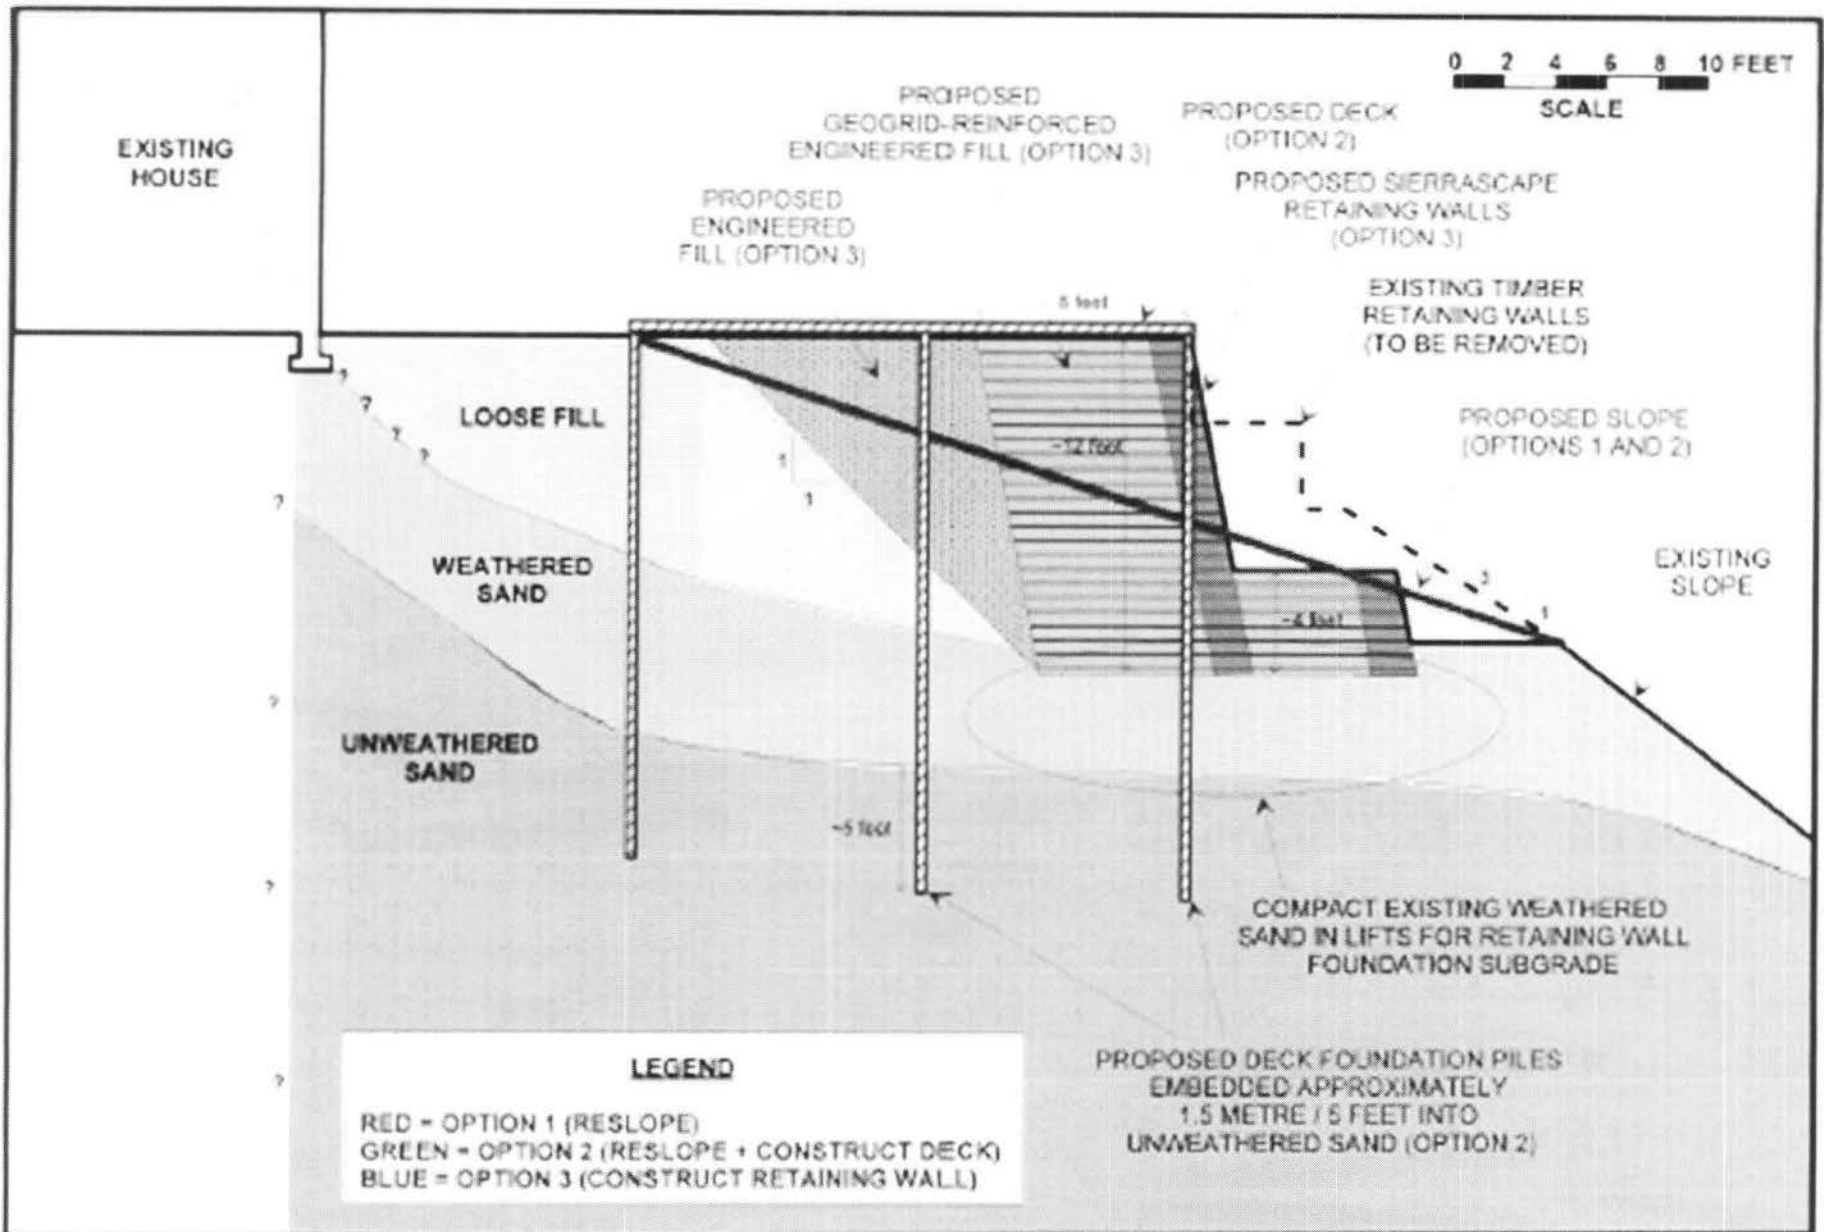
HORIZON ENGINEERING INC	MOSTAFA MADANINEJAD 1576 MERLYNN CRESCENT, NORTH VAN. PROPOSED REMEDIAL EARTHWORKS	SCHEMATIC PROPOSED REMEDIATION OPTIONS SECTION B		Scale AS SHOWN	File NO 113-3422	Date OCT/13	PROJECT
		4

Both geotechnical consultants retained by the District provided the same recommendation of removing the fill load and the removal/replacement of the retaining walls on the property for landslide mitigation.

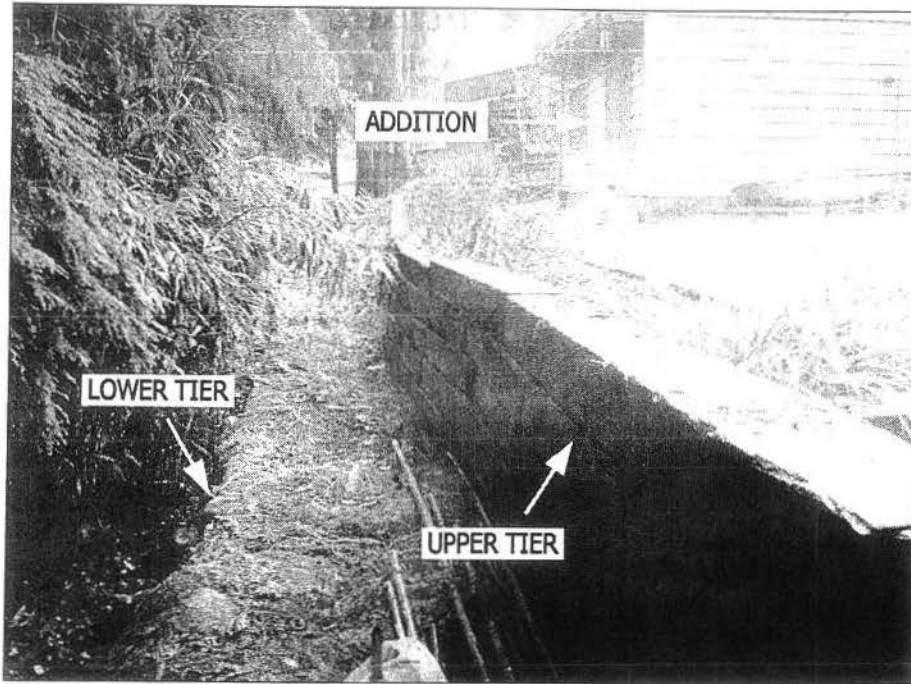
PHOTOGRAPH 1. BULGING TIMBER RETAINING WALL OBSERVED AT 1576 MERLYNN CRESCENT.

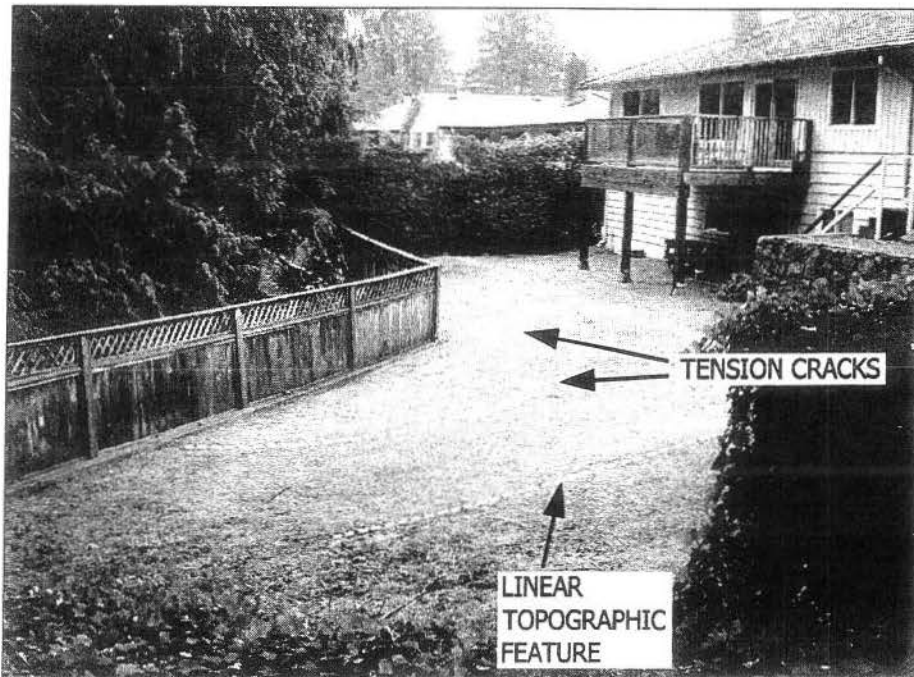
PHOTOGRAPH 2. LINEAR TOPOGRAPHIC FEATURE AND TENSION CRACKS OBSERVED AT 1582 MERLYNN CRESCENT.
