**Re: Slope Hazard Comments – Reorientation & Location Changes
2670 Lloyd Avenue, North Vancouver, B.C.**

The District of North Vancouver REPORT TO COUNCIL

SUBJECT: North Shore Support Recovery House for Women

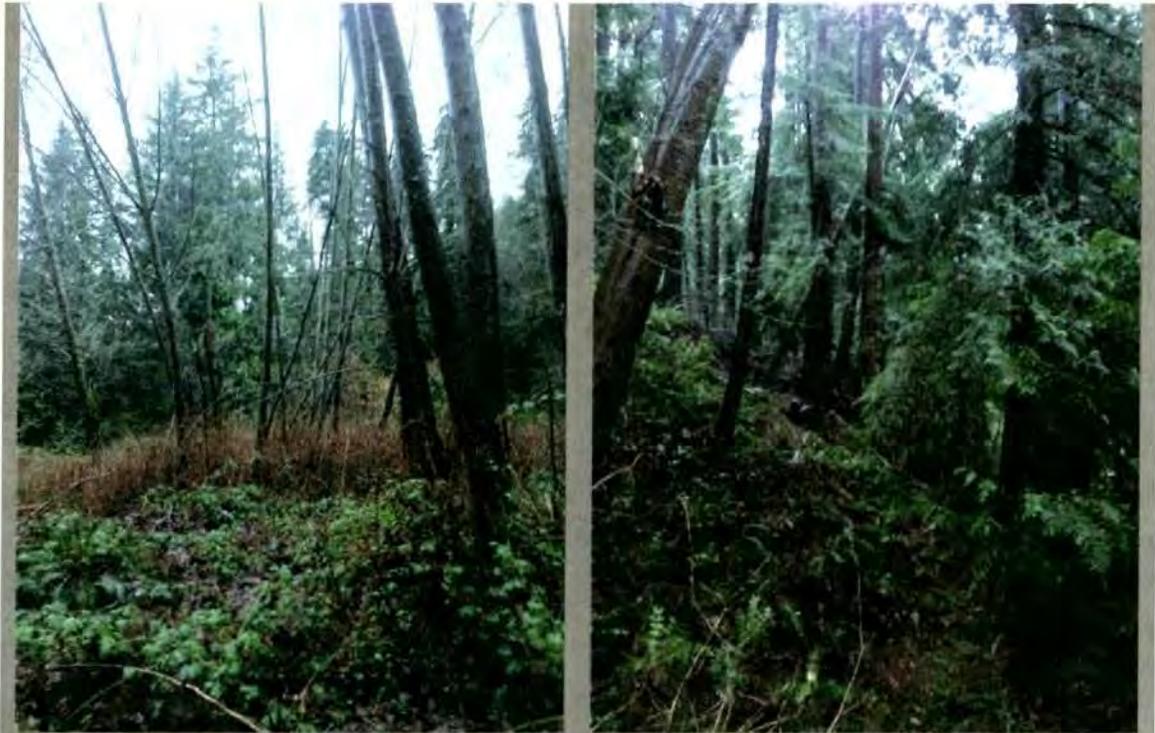
Image 1: View of Stand A from Lloyd Avenue

Image 2: View of Stand B from just north of the project site.

Stand A is located across Lloyd Avenue from the proposed development. It has a high moisture regime and is dominated by deciduous trees species and shrubs with low flammability. There are scattered small pockets or individual conifers in this stand but at a stand composition of less than 20%. The Canadian Wildfire Information System fire behaviour models of this fuel type show that it poses a low wildfire behavior potential. Furthermore, the road to the west will provide a fuel break from any surface fire that might occur in Stand A. As such, Stand A represents a low wildfire danger to the proposed development.

The greatest risk from wildfire to this development is from Stand B, located 8m to the north and 10-20m to the east of the project site. The Canadian Wildfire Information System indicates that due to the high crown base height (>5m) of the mature conifers and the relatively low flammability of the understory vegetation, Stand B would only support a high intensity wildfire under extreme wildfire behavior conditions. Along the stand edge to the north and east of the

- Along the stand edge to the north and east of the project site there are a number of hazard trees that have been identified. These are tagged #593, 647, 653 and 264. These are mostly mature conifers and their removal will reduce the continuity of conifers in this area. This will reduce the fire behavior potential of the crown fuels.

- There are three conifers (#267, 268 and 266) that are directly north and within 10m of the planned structure. These trees form a natural windfirm edge to this stand. The trees to the north would not be as stable once exposed. Therefore it is recommended these three conifers be retained and that the limbs of the crowns be life pruned up to 5m and side-limbed on the south side up to 10m.

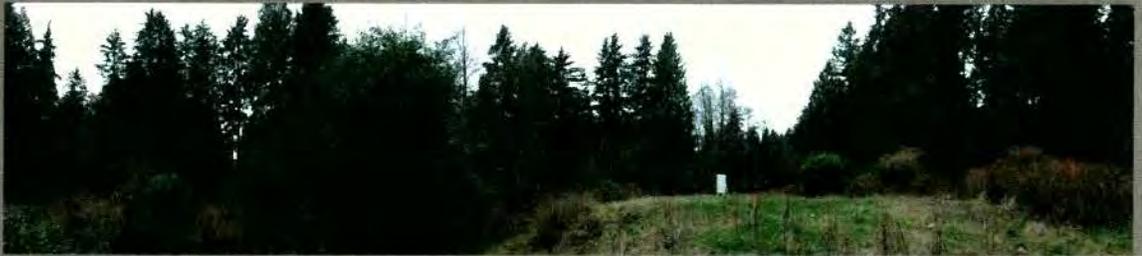
Photo 2. View of the riparian protection area along the south boundary of property .

The trees growing along the creek on the south side of the property consists of a closed stand of young to mature deciduous trees. These are generally growing together as a group in soils with a higher moisture regime. The outer exposed trees have grown in place and have adapted to oncoming winds. The trees in the middle of this stand have a higher height to diameter ratio and generally rely on neighboring trees for stability. A 15m riparian area setback will be established along the creek. This setback requires that measures be taken to ensure the trees remain stable and windfirm. The proposed development does not encroach into the riparian area or create any conflicts with trees in the set back.

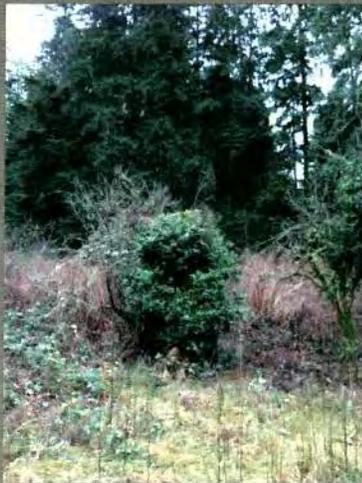
Photo 3. Example of one of the two heritage stumps on site.

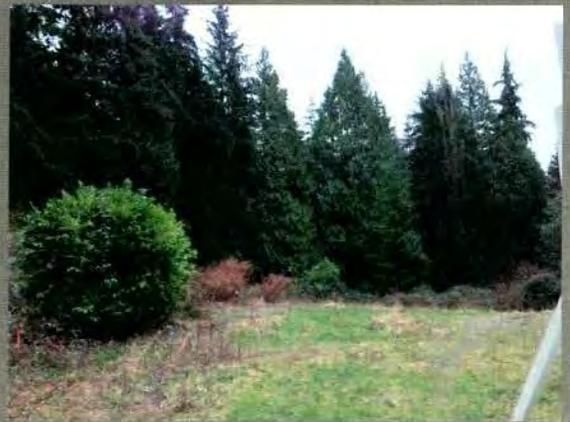
Photo 4. View of the mature conifers on the north boundary of the site.

For wildfire risk mitigation it is recommended that all conifers within 20m of the development should be lift pruned to 5m. There are three conifers (#267, 268 and 266) that are directly north and within 10m of the planned structure. These trees are within the recommended defensible zone to be established for wildfire hazard mitigation. However they form a stable and natural windfirm edge to this stand. The trees to the north would not be as stable once exposed. It is recommended these three conifers be retained and that the limbs of the crowns be lift pruned up to 5m and side-limbed on the south side up to 10m. All small and medium size woody debris from the hazard tree removals must be chipped or removed from the site.

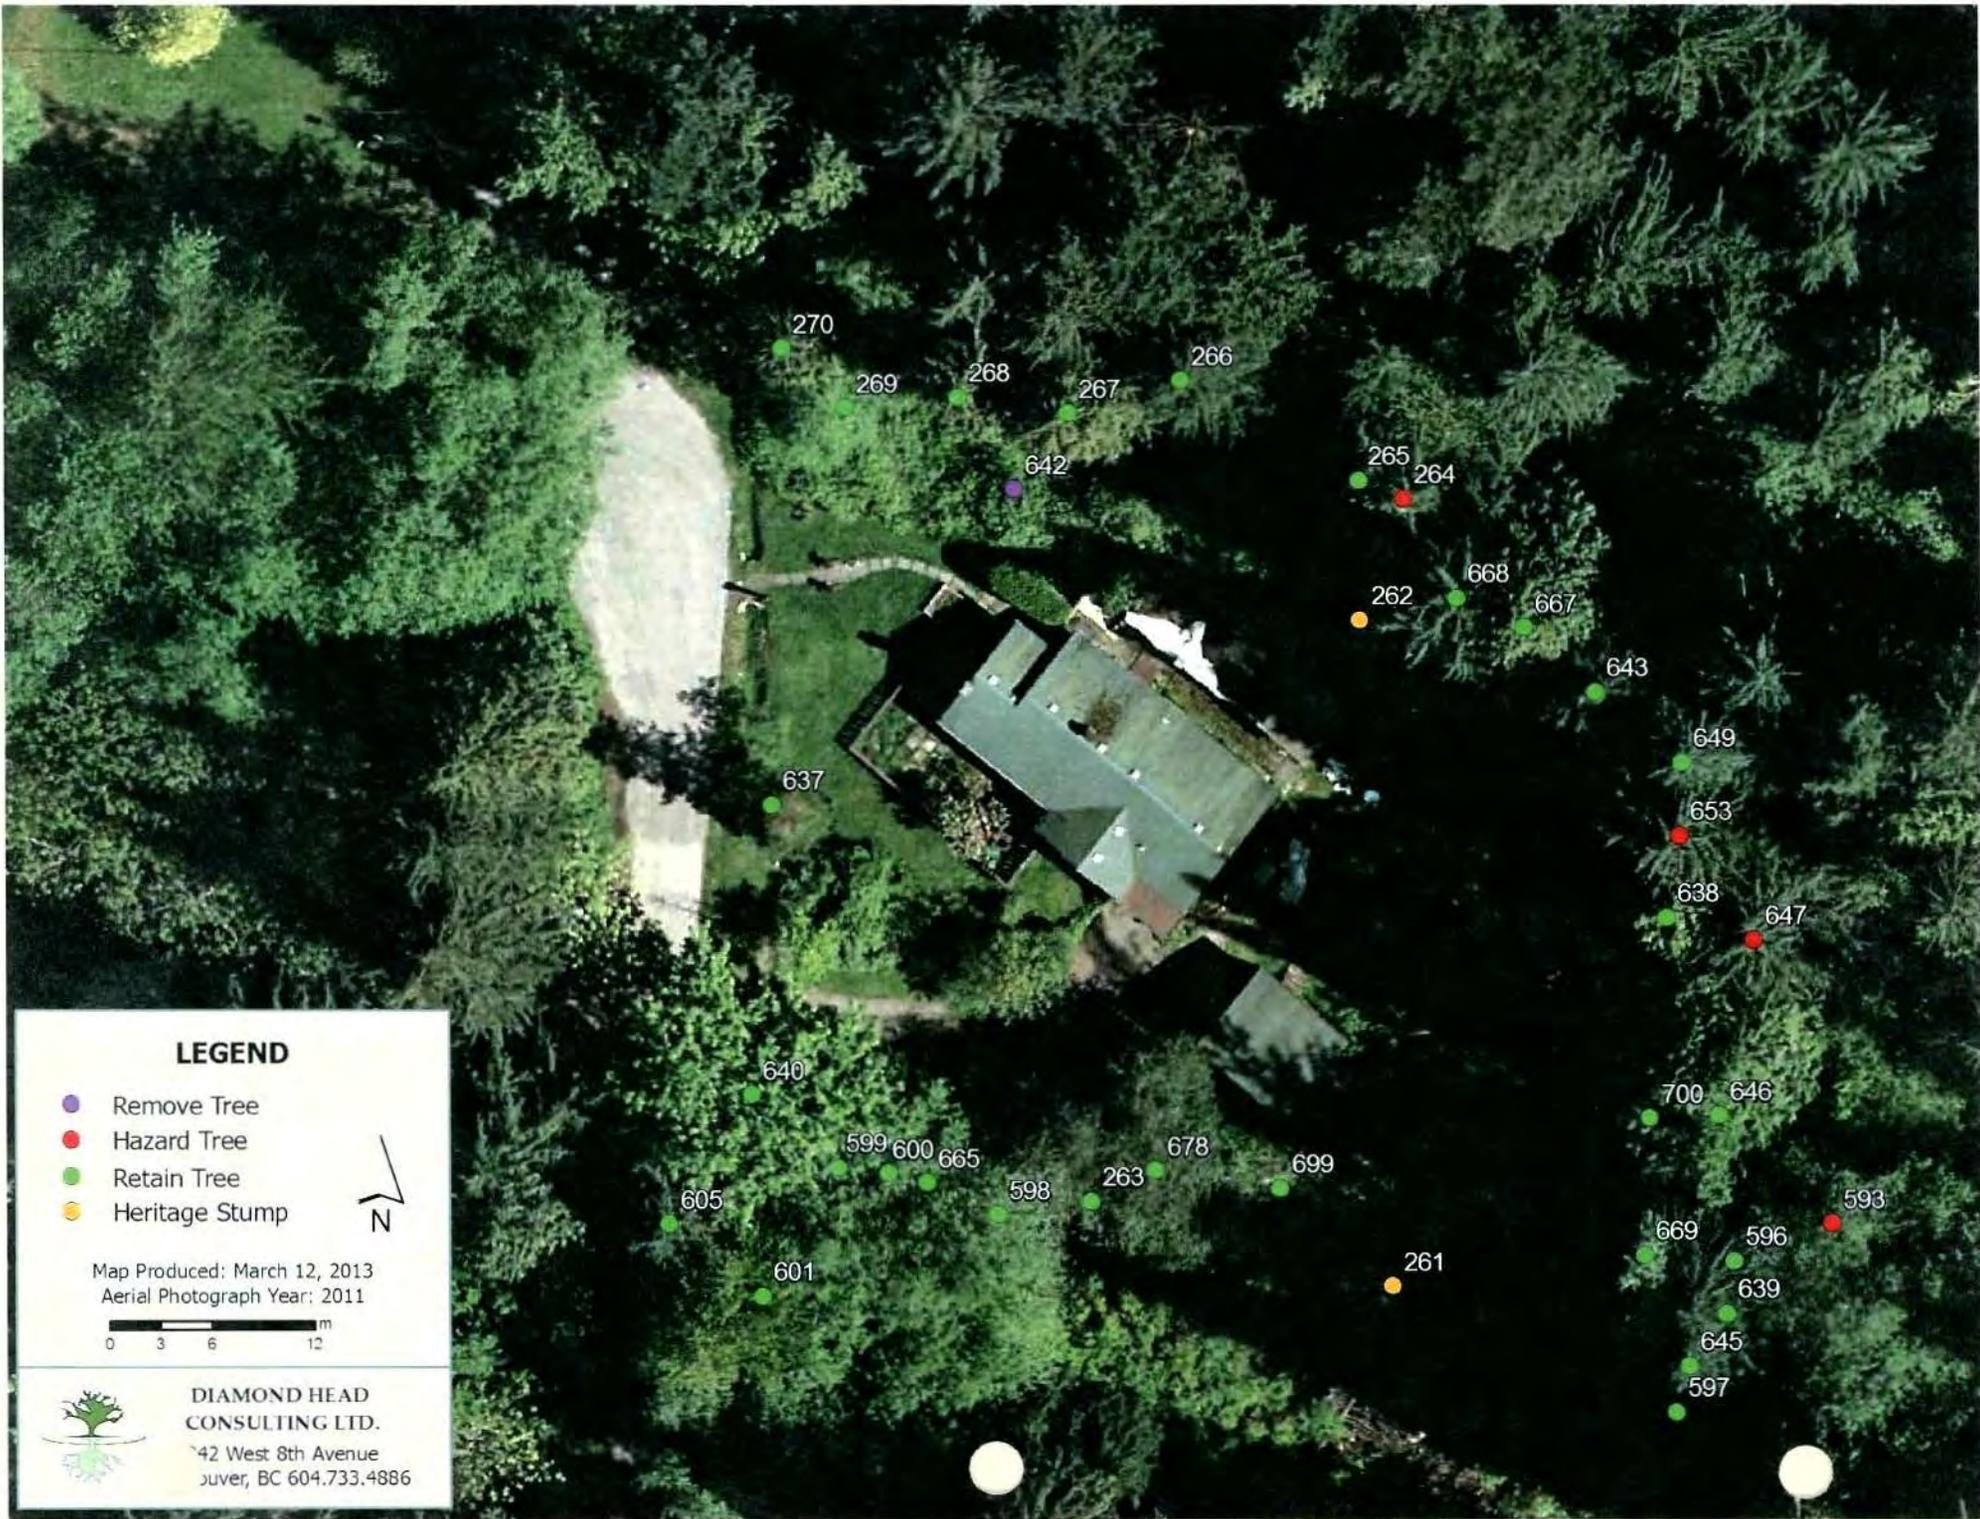
All trees within striking distance of the proposed development, trees in the riparian area (within 15m of the creek), and trees whose roots may be impacted by the development were inventoried in Table 1. Trees that pose a hazard were identified and recommendations for mitigation or removal are provided.

The site inventory identified 34 trees (<20cm diameter) and 2 heritage stumps on and immediately adjacent to the subject site. All trees are on District land and therefore are protected under the tree bylaw. Four of these trees (tag # 0264, 593, 647, 653) will need to be removed to mitigate any hazards to the potential development. One tree (#642) should be removed as it is in poor condition and will be in conflict with the planned building. One large cedar (tag # 596), with multiple tops will require strategic pruning only if the development plan changes and buildings are situated closer to the tree. The hazard tree removal work will not create a new stand edge and the stability of surround trees should not be affected. All work must be done by an experienced ISA Certified arborist and all slash debris must be chipped or removed from the site to mitigate wildfire hazard concerns.
