## The District of North Vancouver REPORT TO COUNCIL

**SUBJECT:** Bylaw 8098 (Rezoning Bylaw 1323): Subdivision of 2698 Violet Street

## ARBORIST REPORT

2698 VIOLET STREET, NORTH VANCOUVER

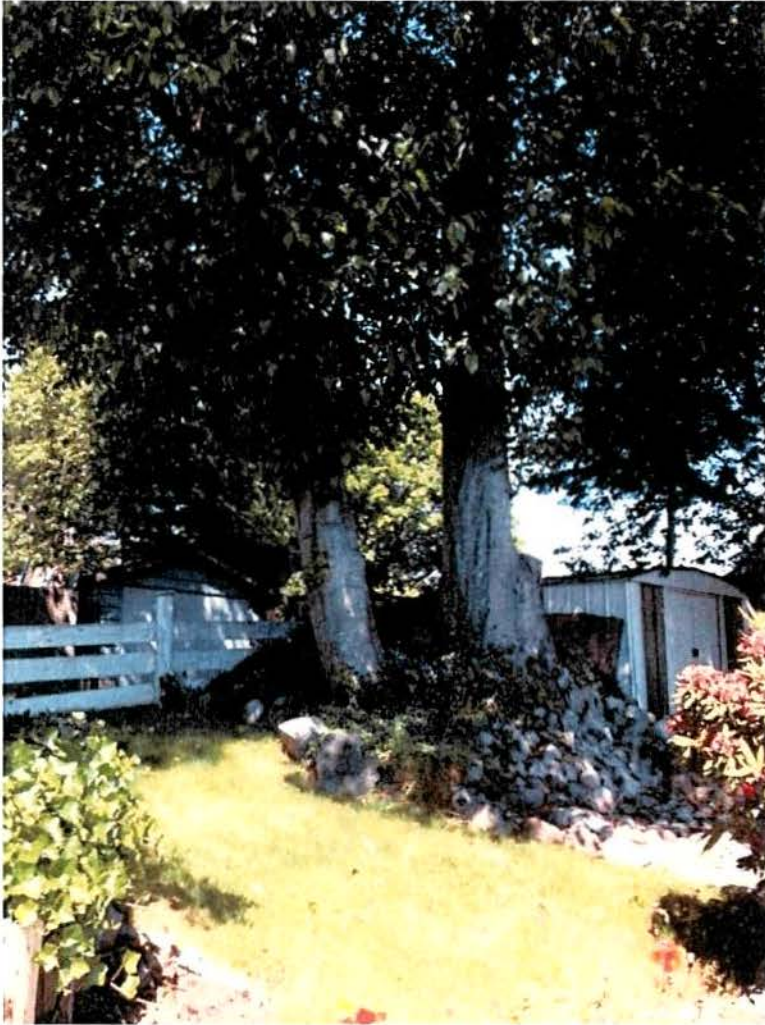
The two mature red alder (Figure 1) situated near the north end of the property are in declining health and hold little long term retentive value. Evidence of significant internal fracturing and lean was noted on tree 1 (Figure 2). Tree 2 is another red alder situated within a metre of tree 1 and while it shows moderate exterior form and structure, the ability of this pioneer species to adapt and thrive as a standalone tree is doubtful.

Figure 1. Two mature red alder trees #1 and #2 in declining health at the rear or North end of the property.

Removal of both tree 1 and 2 is recommended.

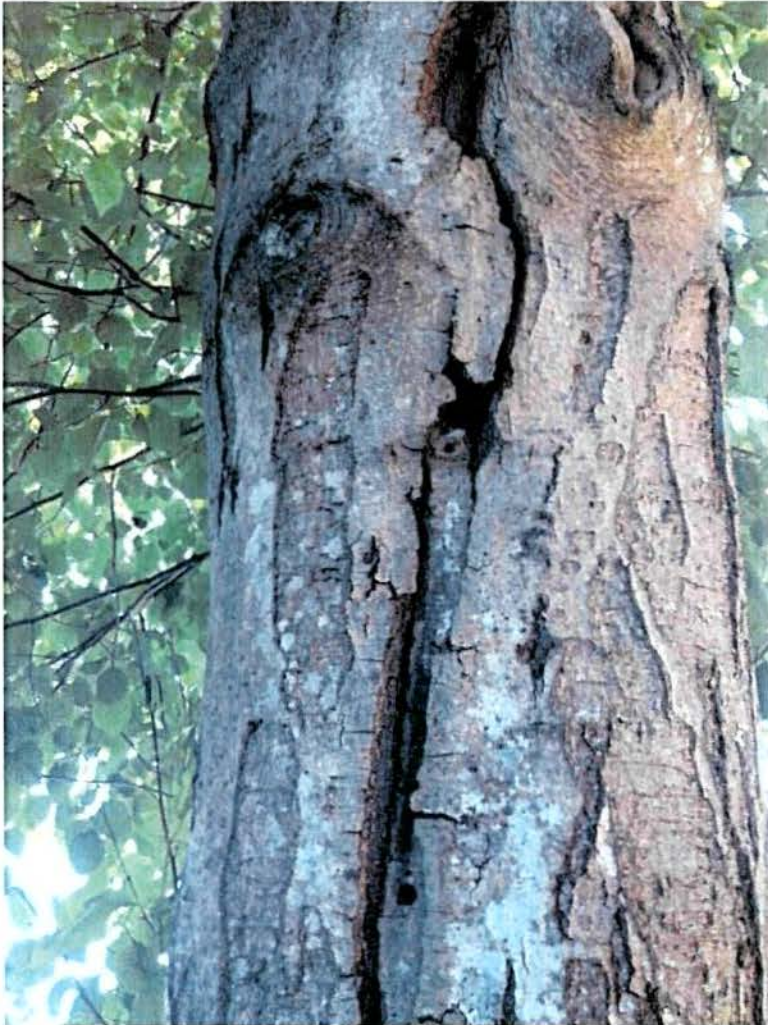
Figure 2. Red alder tree #1 with significant internal fracture and lean.

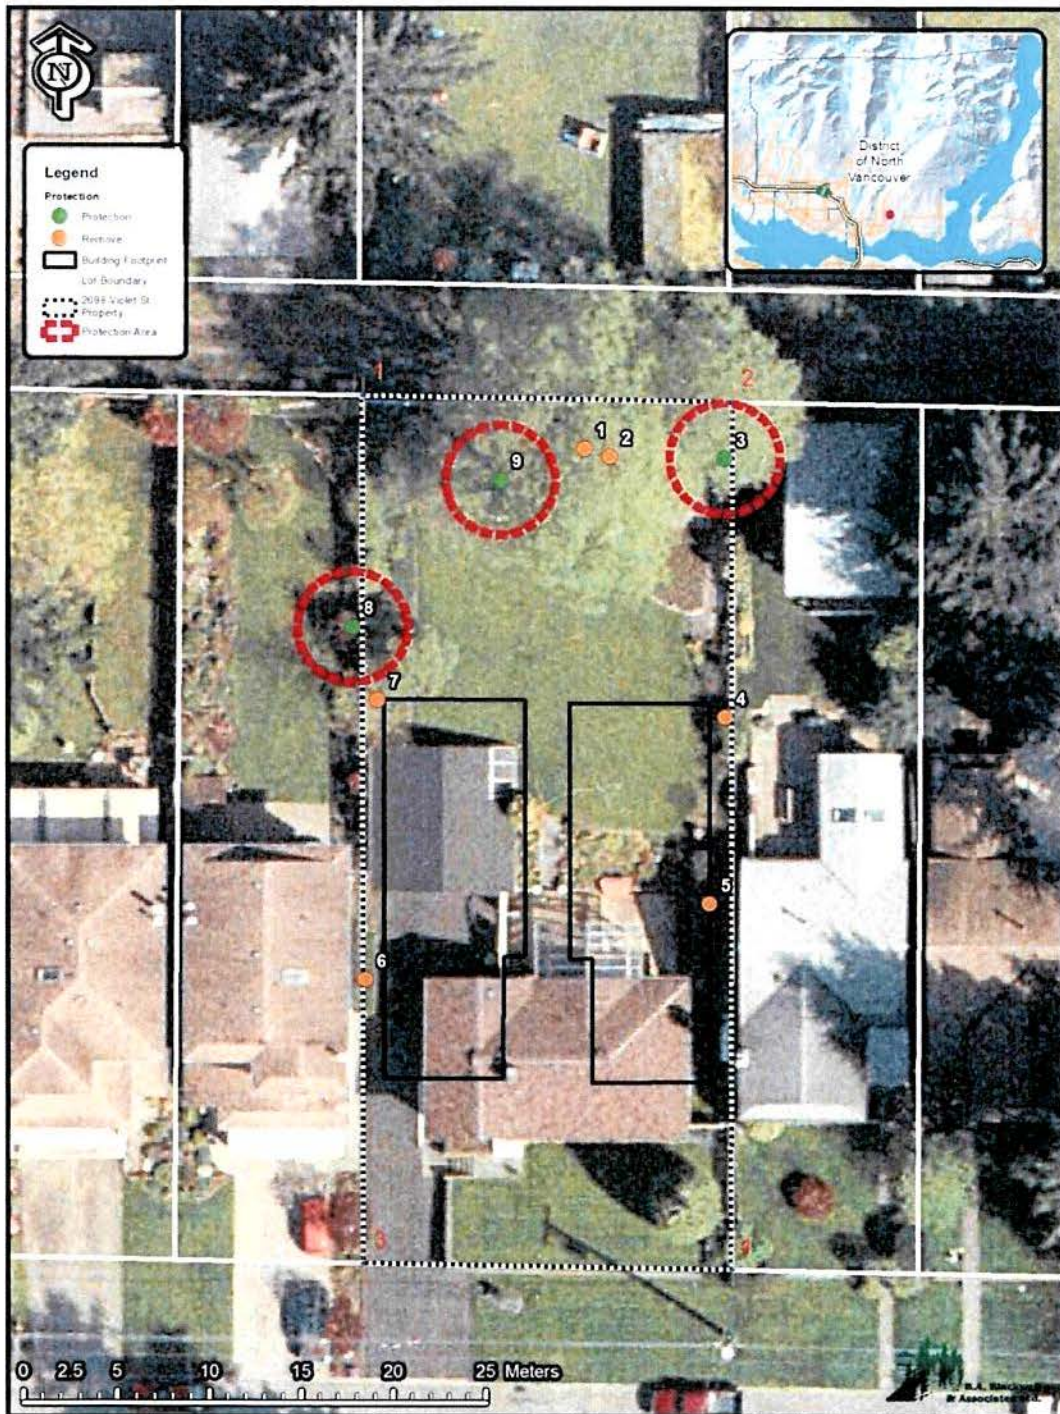
Figure 3. Map of 2698 Violet Avenue in the District of North Vancouver indicating trees for protection and removal.

1. Seek a permit for the removal of trees listed in Table 1.
2. Prior to any demolition or construction, protective fencing must be constructed and maintained for the duration of the project. Six times the diameter was used as the optimal root protection zone (RPZ).
