Arborist Report

Date of Report: November 23, 2012 **Client Name:** Synthesis Design
962 Montroyal Blvd., North Vancouver
File # 12-089.1
Date of Site Review: November 23, 2012 **Site Address:** Same
Weather: Rain, low to Moderate winds **Arborist:** Sean Wightman
ISA Certified Arborist #PN 2013
Certified Tree Risk Assessor #052

Purpose: Burley Boys enterprises LTD. has been contracted to provide a tree retention outline for the significant trees on properties adjacent to the proposed sub-division at 962 Montroyal. This includes the three Western red cedar (*Thuja plicata*) trees located on the district boulevard in front of 958 Montroyal, and a cypress / laurel hedge located on the west neighbour's property, along the property line. The property at 962 Montroyal is proposed to be subdivided. Plans include the retention of the three trees and the hedge detailed within this report.

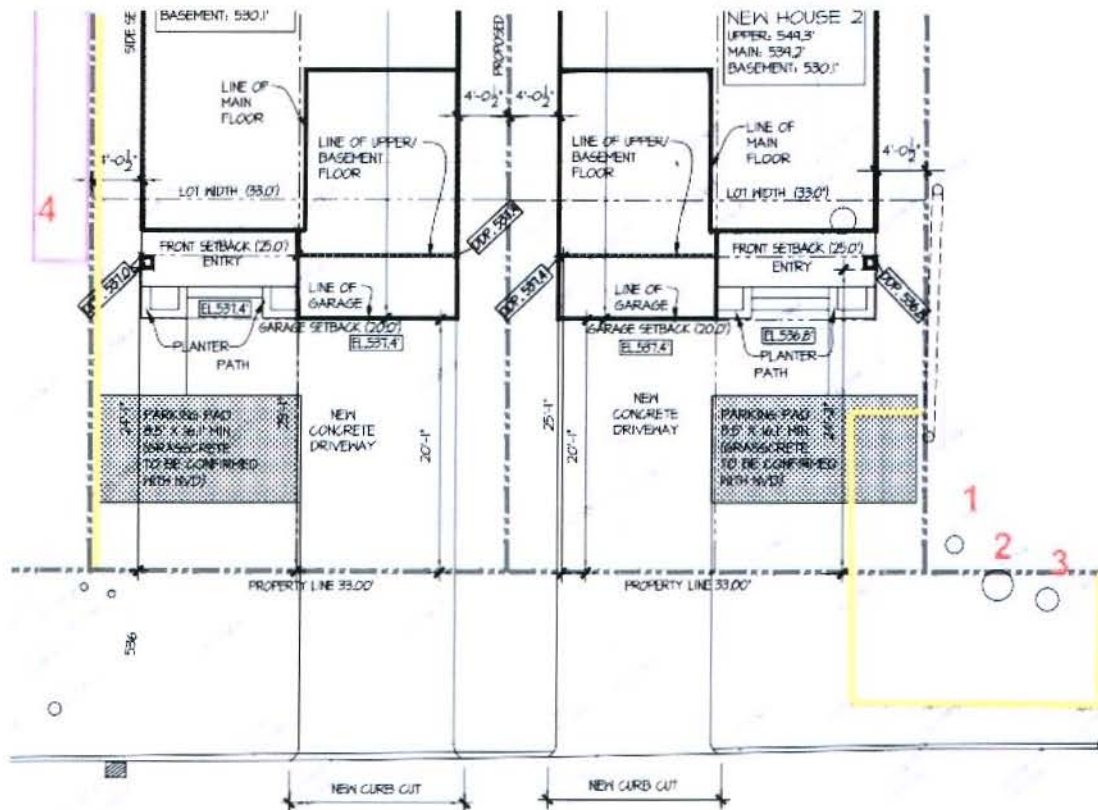
Images: Site plan. Location of tree protection fencing show as yellow lines. These fences must remain in place during the entire heavy construction period which includes all excavations, hardscape construction and any use of heavy machinery on the site.

Tree retention outline: A tree preservation fence must be constructed around the root areas of all trees that are to be retained. Wherever possible, the radius of the tree preservation fence should extend as far as the drip line of the tree's canopy. If this is not possible, the fence should be located no closer than the determined CRZ for each individual tree. This will ensure that critical root zone for each tree is protected and will help reduce the amount of soil compaction to the root areas.

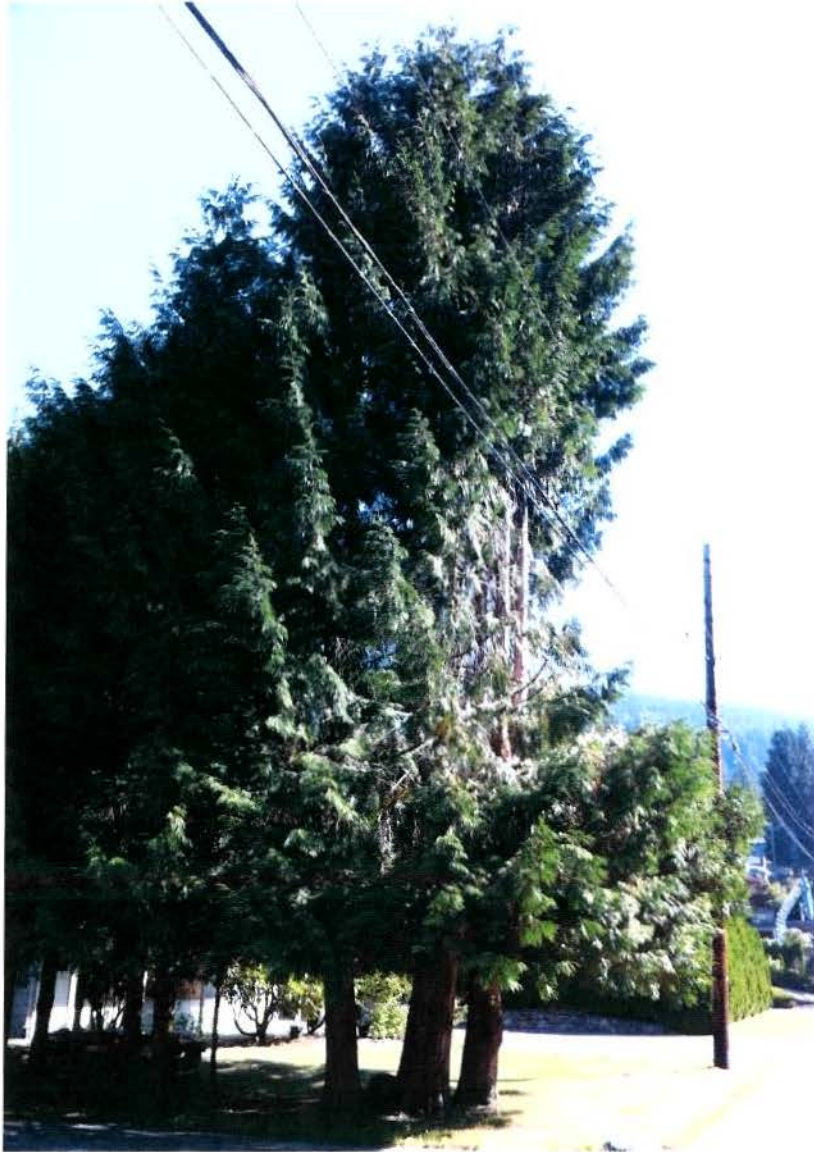
Observations: The three trees in question are located on District blvd in front of the property east of 962 Montroyal blvd. They have grown in a tight grouping near the property line. Their general condition is noted as being "fair"; they have been previously topped, and have had the south side of their canopies pruned for clearance to the hydro lines which run along the street. The trees are not individually tagged, but they are referred to by numbers on the provided site and survey plans. They are referred to below in Appendix A by these same numbers.

Trees 1, 2 and 3 (nearest to street). Smaller trees seen in the left of the image are to be removed with confirmation from property owner.

Arborist supervision: Any excavations or grade changes near or inside of any tree's CRZ should be supervised by an arborist to identify, document and mitigate any damaged roots. This should include the removal of the existing black top driveway which is located within the CRZ's of trees 1, 2 and 3. It is expected that this black top can be removed without causing any significant damage the future health or sustainability of these trees.

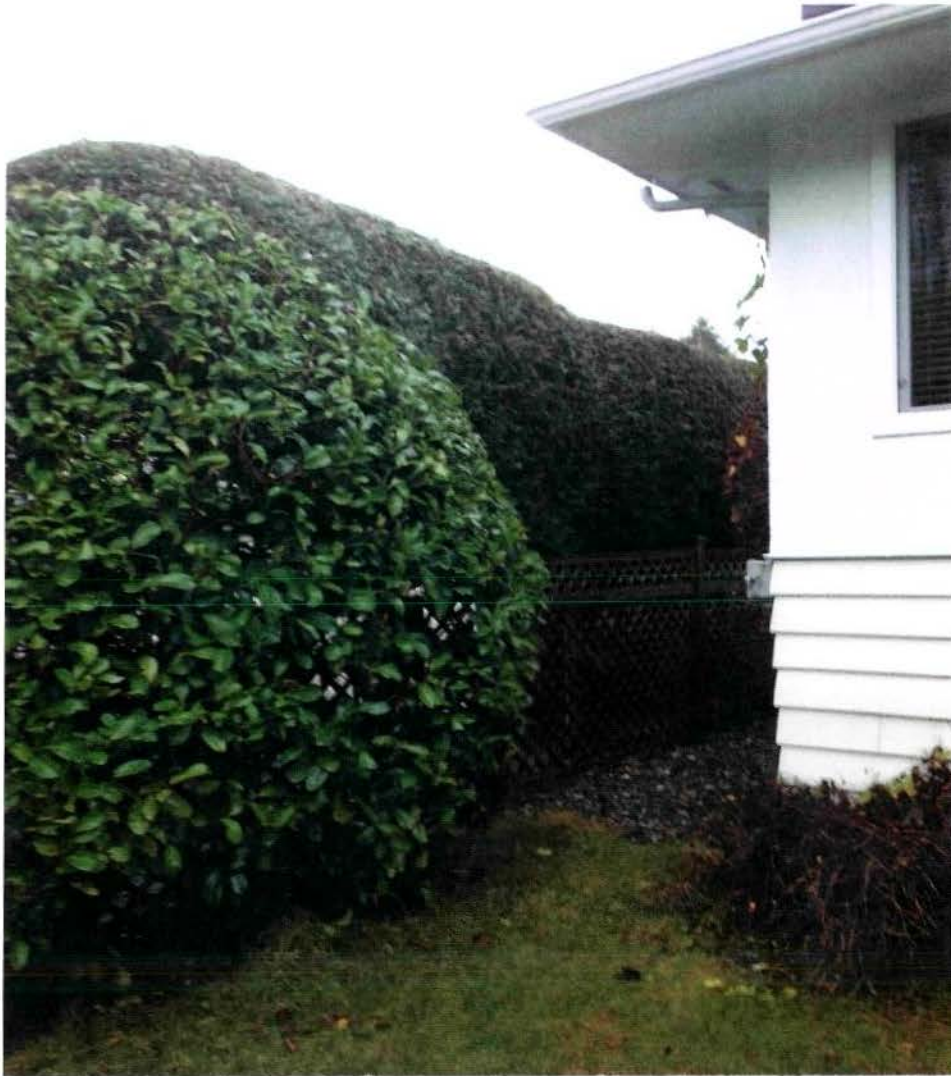
West Neighbour's hedge (Tree #4). Tree protection fencing to run along property line.
