PUBLIC HEARING BINDER

Bylaw 8187: Heritage Revitalization Authorization Agreement Bylaw

(114 West Windsor Road – Green Gables)

CONSERVATION PLAN

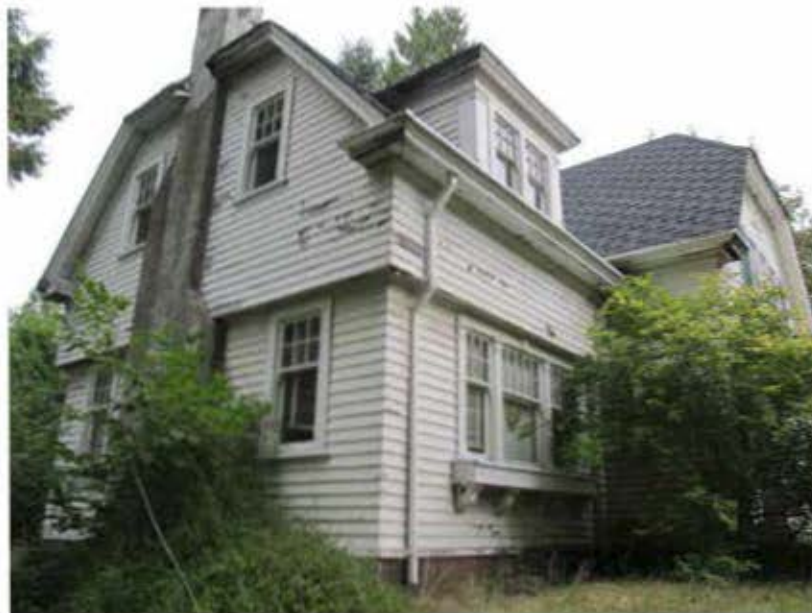
Southwest corner of Green Gables. Note brickwork below exterior wood siding along foundation wall.

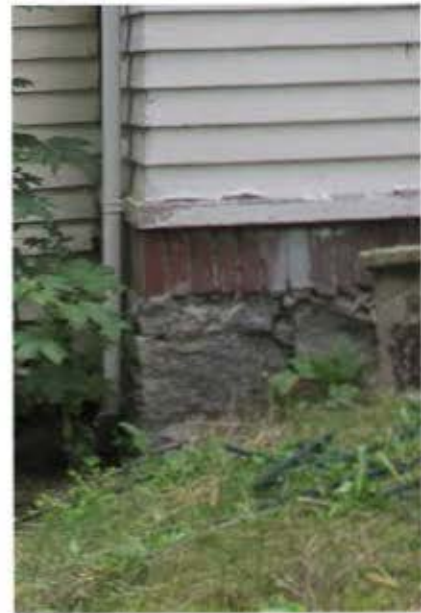
The existing foundation was not reviewed in detail, but it was noted that it consists of granite stone foundation, with red brick masonry units laid in soldier course directly above the stone foundation as it transitions to the exterior wood siding.

Detail photo showing existing condition of foundation wall.

The existing foundation will be rehabilitated as part of the façade retention, including necessary seismic reinforcements. Careful attention should be executed to ensure the exterior walls above grade, particularly the front façade, are not damaged during rehabilitation work.

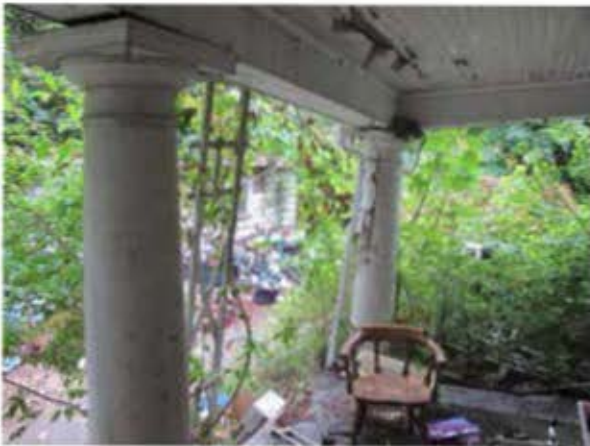
Existing condition of side porch

At the time of the inspection, the porch columns have localized dry rot, particularly at the base. The northernmost column has been removed from its original location, but the item was found intact, with minor damages, and is stored on site.

The tongue-and-groove decking appears to be in poor condition, showing signs of deterioration in localized area. The soffit is slanting with the beams, but the material appears to be in good condition. The siding on the later enclosure of the north portion of the porch matches the dimensions of the original siding, and has been meticulously aligned.

In general, the porch appears to be structurally unsound, and may need to be demolished and reconstructed to match original historic configuration. Further investigation is required to confirm that the existing conditions do not have structural implications.

- Existing porch should be carefully documented prior to careful dismantling of the existing porch.
- Investigate condition of original wood elements. Salvage sound original wood elements that can be cleaned and reused for reconstruction of side porch as possible.
- Restore the side porch to match original detailing, using salvaged original wood elements, and repair as necessary.
- Replace in-kind missing or deteriorated parts to match existing condition. New replica wooden elements should match in-kind the old in form and detailing.
- Paint exposed woodwork in historically appropriate colour.

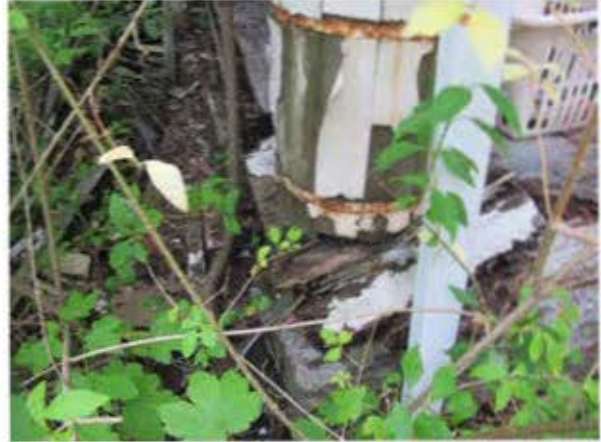
Example of dry rot on side porch column base

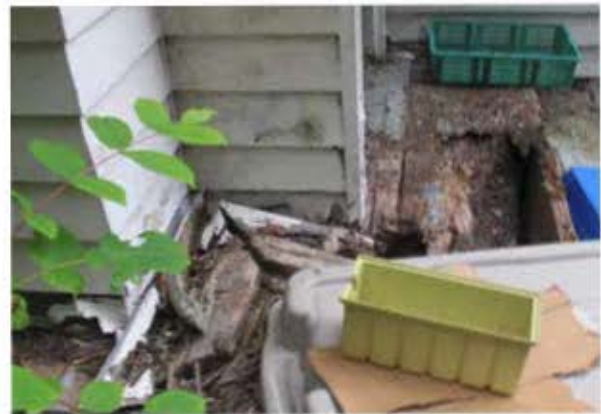
Example of dry rot on side porch

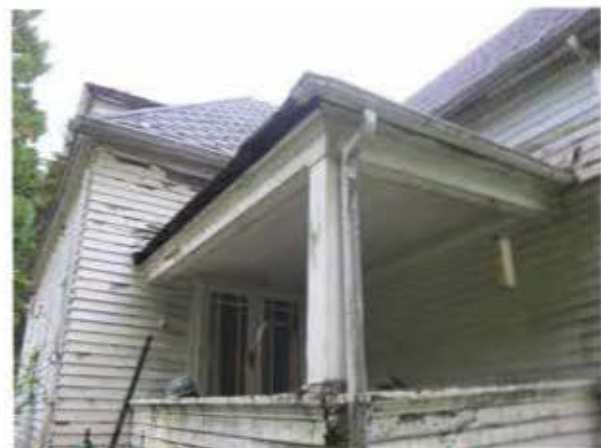
The columns appear to be in good condition, but the uneven settling of the porch caused the beams and balustrade to slant and detach from the exterior walls. The soffit also slants with the beams, but the material appears to be in good condition. The decking was covered at the time of the inspection and was not reviewed.

In general, the porch also appears to be structurally unsound, and further investigation is required to confirm that the existing conditions do not have structural implications. A new upper floor deck may be added at this location.

Existing condition of rear porch

Conservation Strategy: Demolition

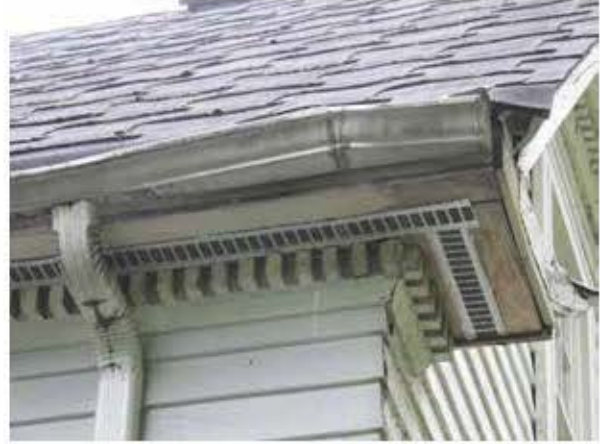
The existing roof of Green Gables features replacement asphalt shingles, as well as later gutters and downspouts. In general, these elements are in poor condition, showing signs of visible deterioration, and should be replaced with appropriate materials that are sympathetic to the historic character of the heritage property.

Detail photos showing typical deteriorated condition of asphalt-shingled roof along gutter and eaves.

- Retain the original wood elements. If required, repair or replace in-kind damaged or missing wood elements such as bargeboards, soffits, raftertails, and trim.
- Design and install adequate rainwater disposal system and ensure proper drainage from the site is maintained. Wood gutters with galvanized steel downspouts are recommended. Aluminum in appropriate colours is also acceptable. Paint or provide specification of drainage system elements according to colour schedule devised by Heritage Consultant.

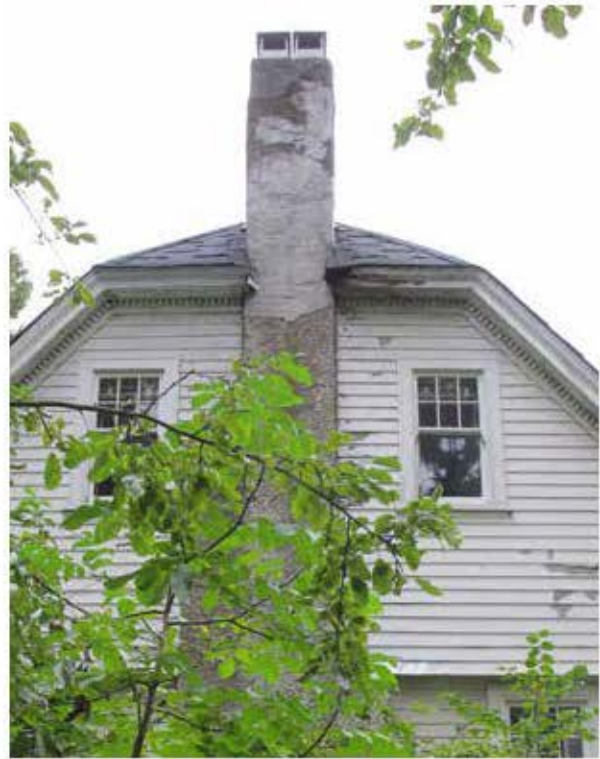
Typical existing condition of exterior brick chimney with later rough-cast stucco.

- Preserve the chimney in its original configuration, if possible, and replace later concrete caps with historically appropriate chimney cap. Alternatively, reconstruct chimney with salvaged bricks to match historic appearance above the roofline, if unable to be retained in situ due to structural reasons.
- Existing chimney should be carefully documented prior to careful dismantling of the existing chimney.
- Remove unsympathetic stucco rendering.
- Investigate condition of brickwork. If required, brickwork may be repointed and cleaned using a natural bristle brush and mild rinse detergent.
- Cleaning, repair and repointing specifications to be reviewed by Heritage Consultant.

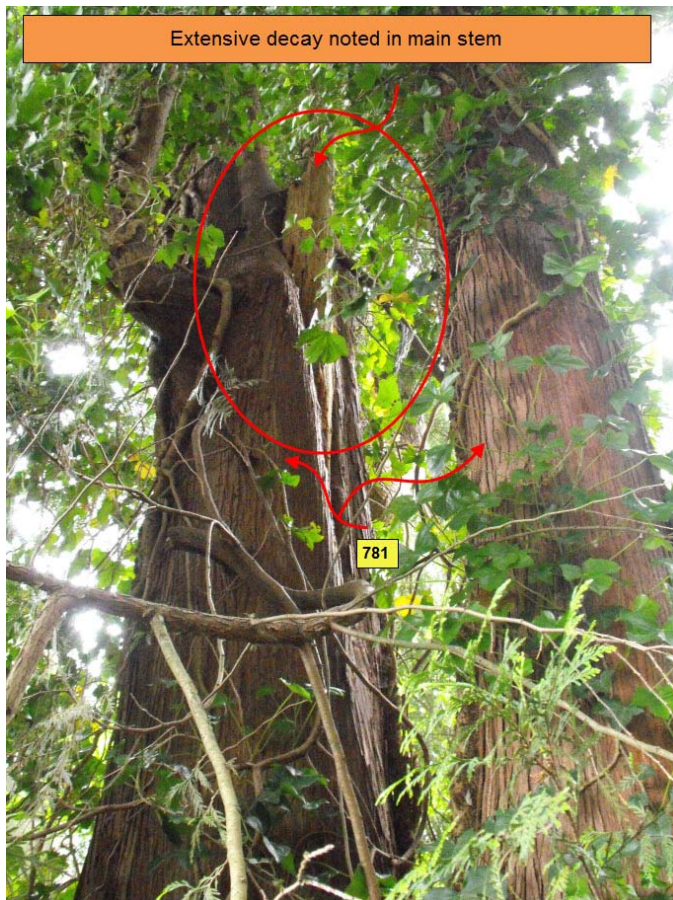
Picture 9. Tree #781 – decayed stems

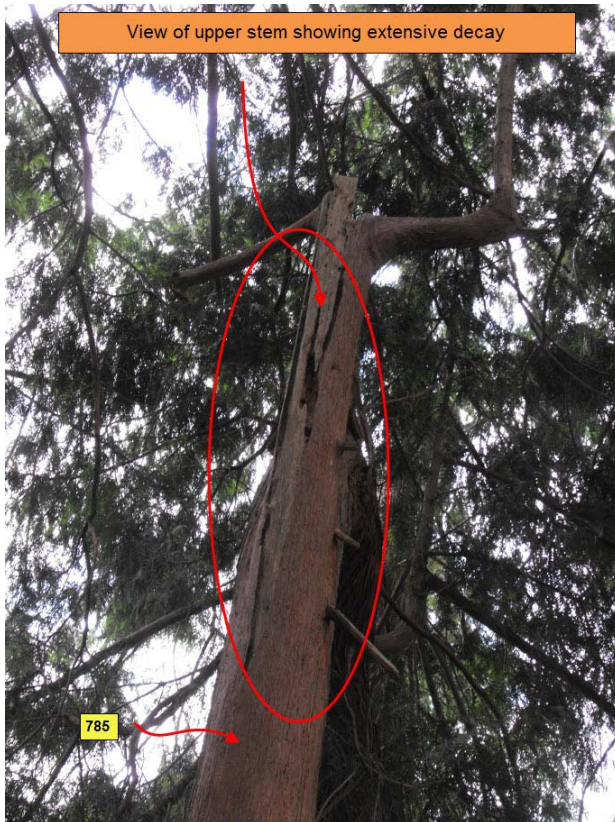
Picture 12. Tree #785 – decay in upper stem

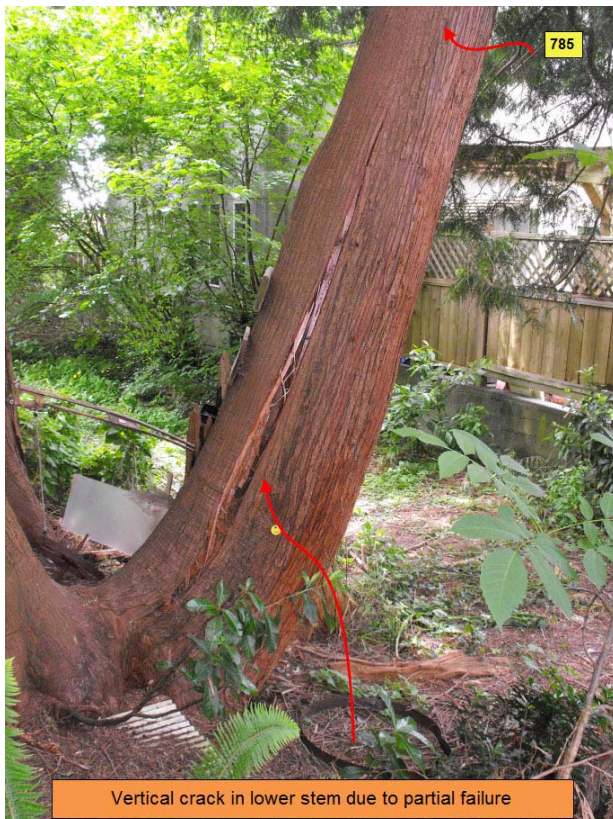
Picture 13. Tree #785 – crack in lower stem

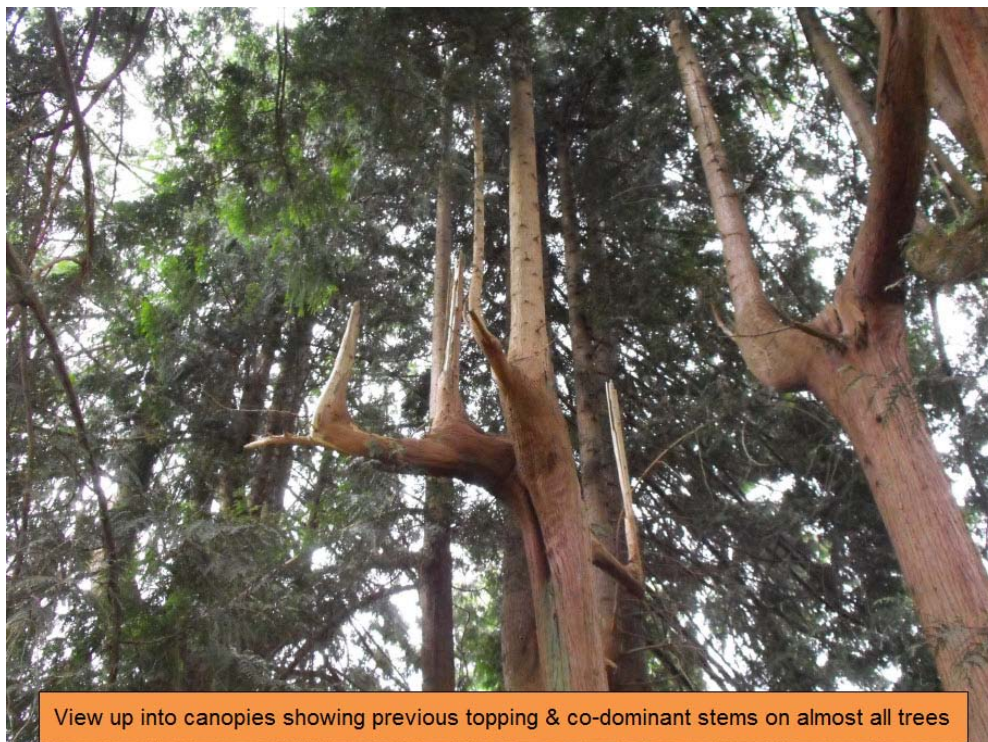
Picture 15.
Site trees
have been
previously
topped & co-
dominant
stems have
grown

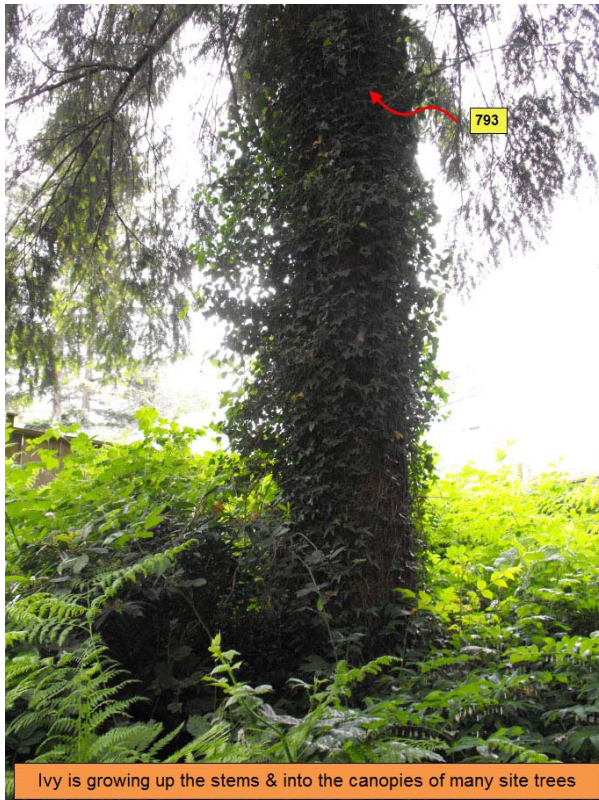
Picture 18. Ivy is established on trees

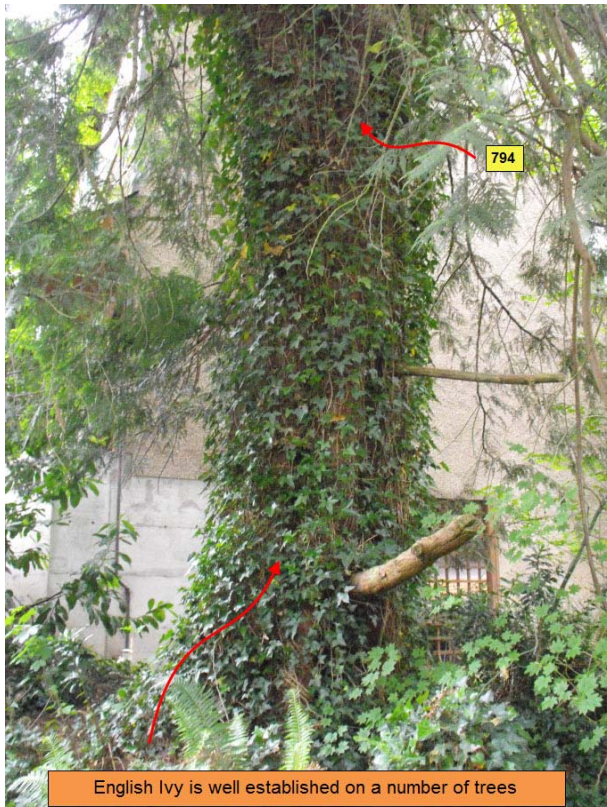
Picture 19. Ivy is established on trees

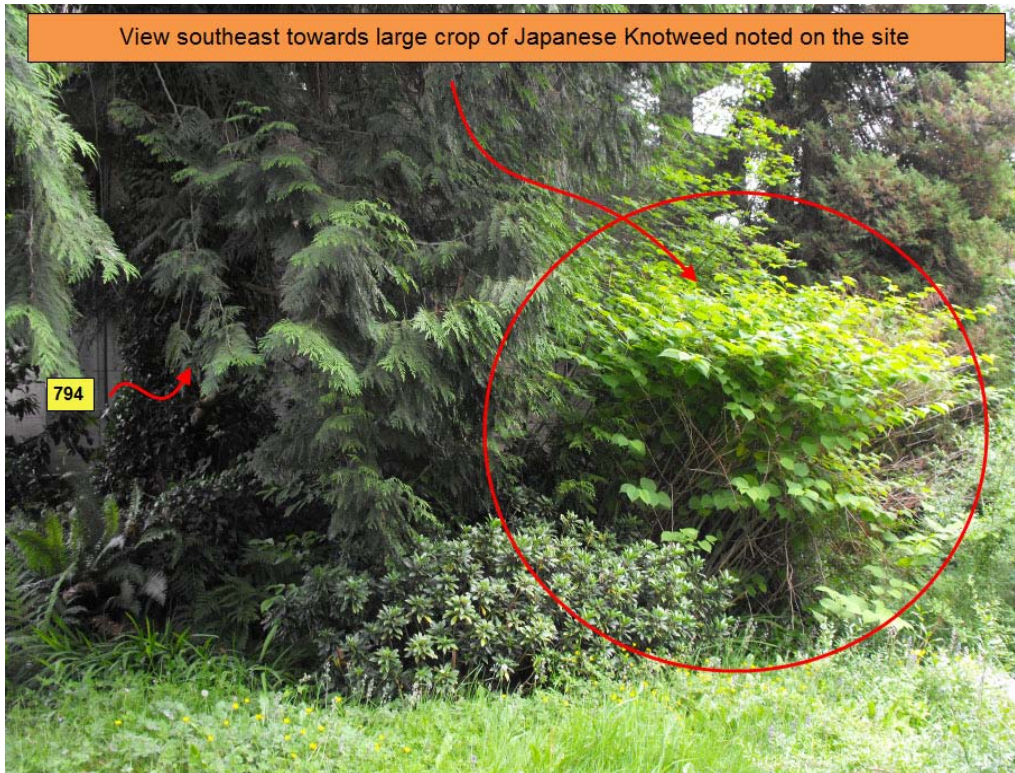
Picture 20. Japanese Knotweed identified on site
