# AGENDA ADDENDUM

## *REGULAR MEETING OF COUNCIL*

**Monday, July 23, 2012**

- 8.5. Bylaw 7939: Zoning Text Amendment – The Corner Store** **p. 7 - 9**  
File No. 08.3060.20/037.12

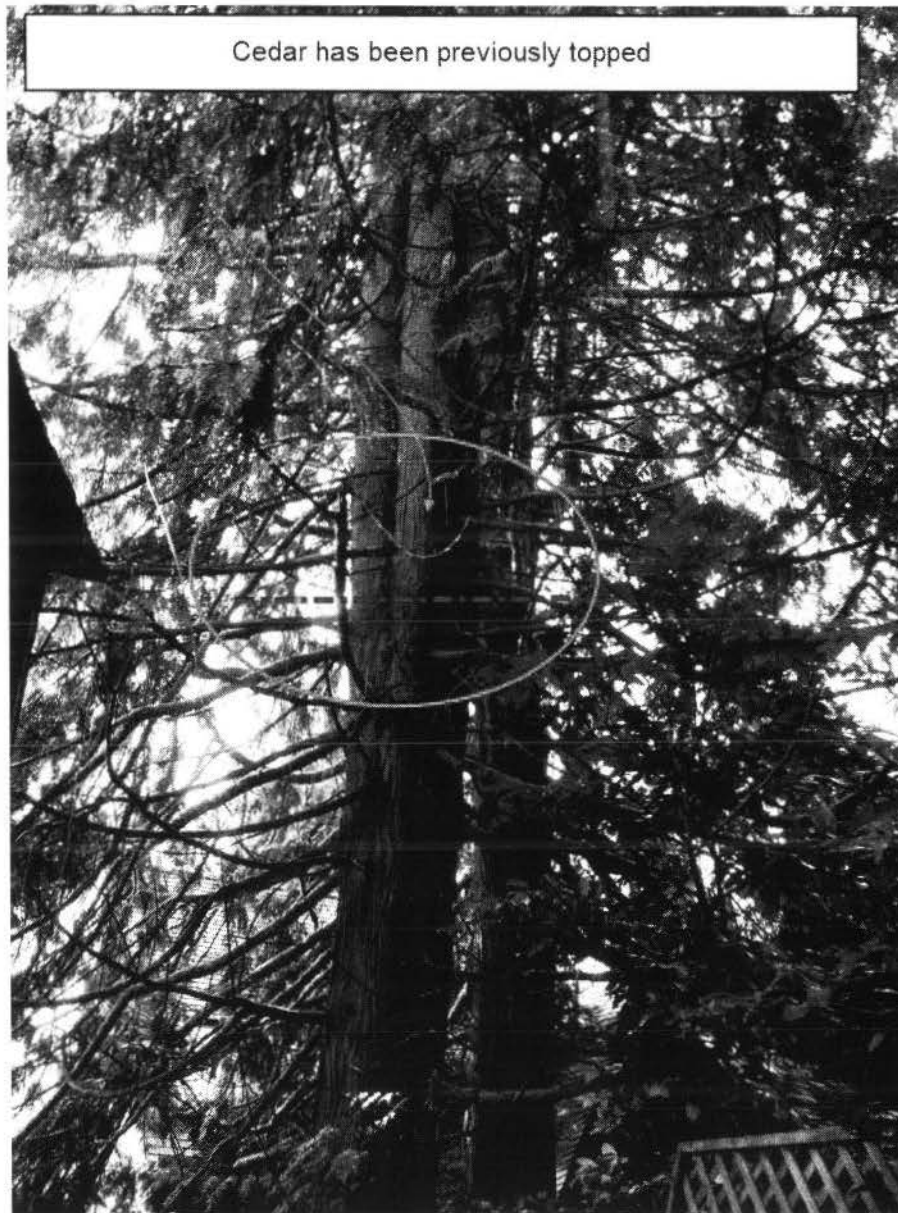
These trees are considered to have a high live crown ratio and moderate trunk taper. *Live Crown Ratio* is defined as the ratio of the vertical extent of the live crown, compared to the overall height of the tree. Tapered trunks will withstand greater stress (*wind, vandals, snow load etc*) than those that have little to no taper. Tapered trunks also allow for a more uniform distribution of the stress that will be imposed on the tree. The taper in a tree trunk decreases in diameter the higher up the tree you go. Mechanically the tops of well-tapered trunks are more apt to bend under the wind further from the vertical than those with less taper. This reduces the danger of broken trunks or other deformation from exposure to the heavy winds.

Picture 4. Previous topping point - Cedar

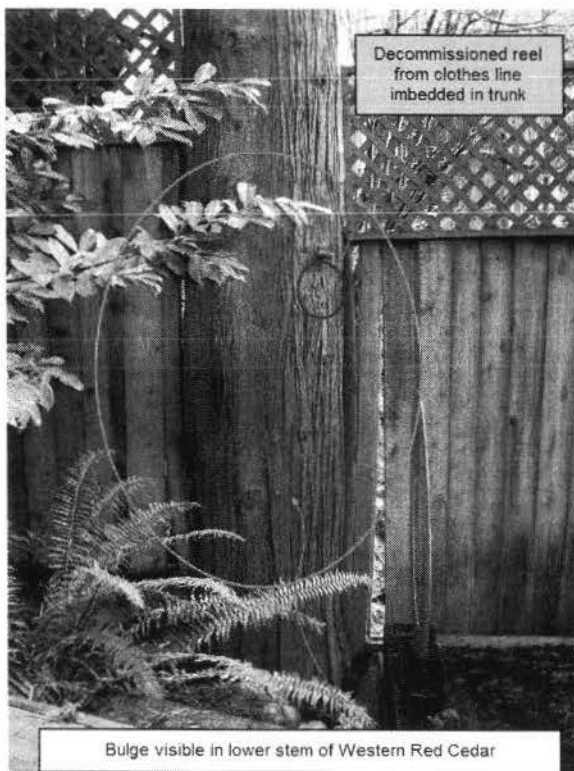
Picture 5. Bulge visible in Cedar trunk

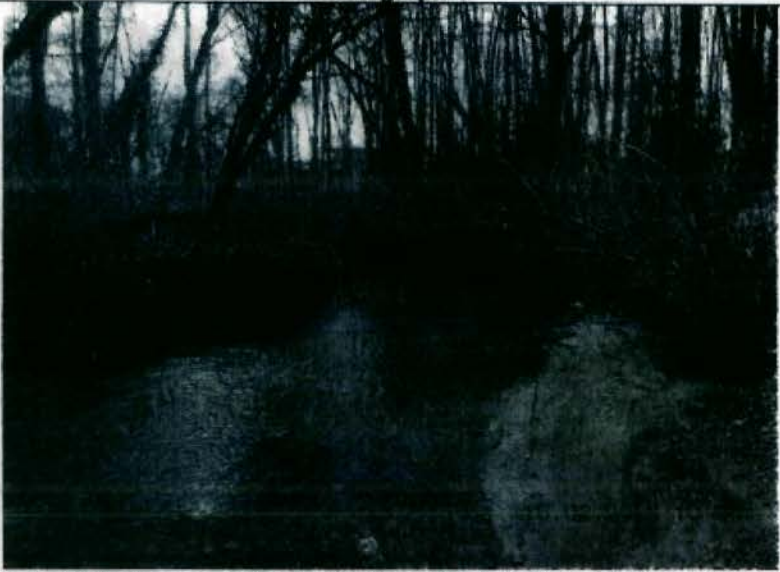
| Label | <p><b>Photograph 4</b></p> <p><b>MacKay Creek and riparian vegetation; sand deposition in bottom right hand corner is this wider spot has resulted in sidebar formation</b></p> |

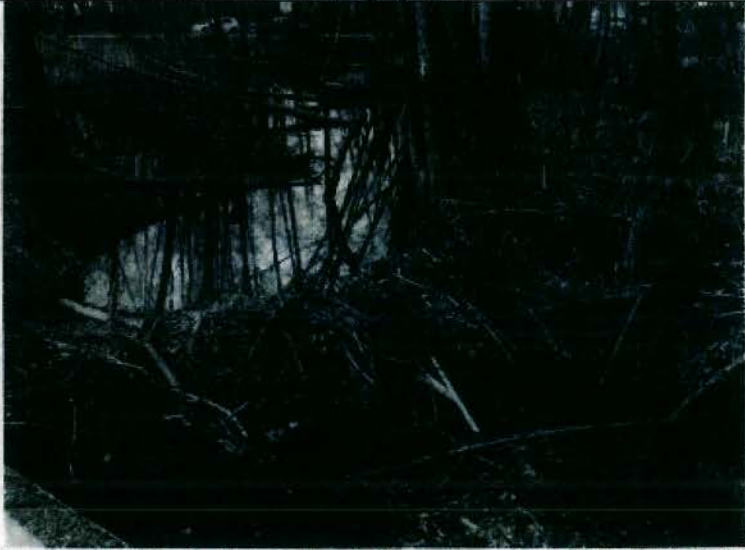
| Label | Photograph 6 |

| | <p>The MacKay Creek wetland: a beaver dam in the foreground and felled trees in background provide LWD and water retention.</p> |
