SEYMOUR SALMONID SOCIETY

Seymour River Rock Fall

Restoration of Fish Passage

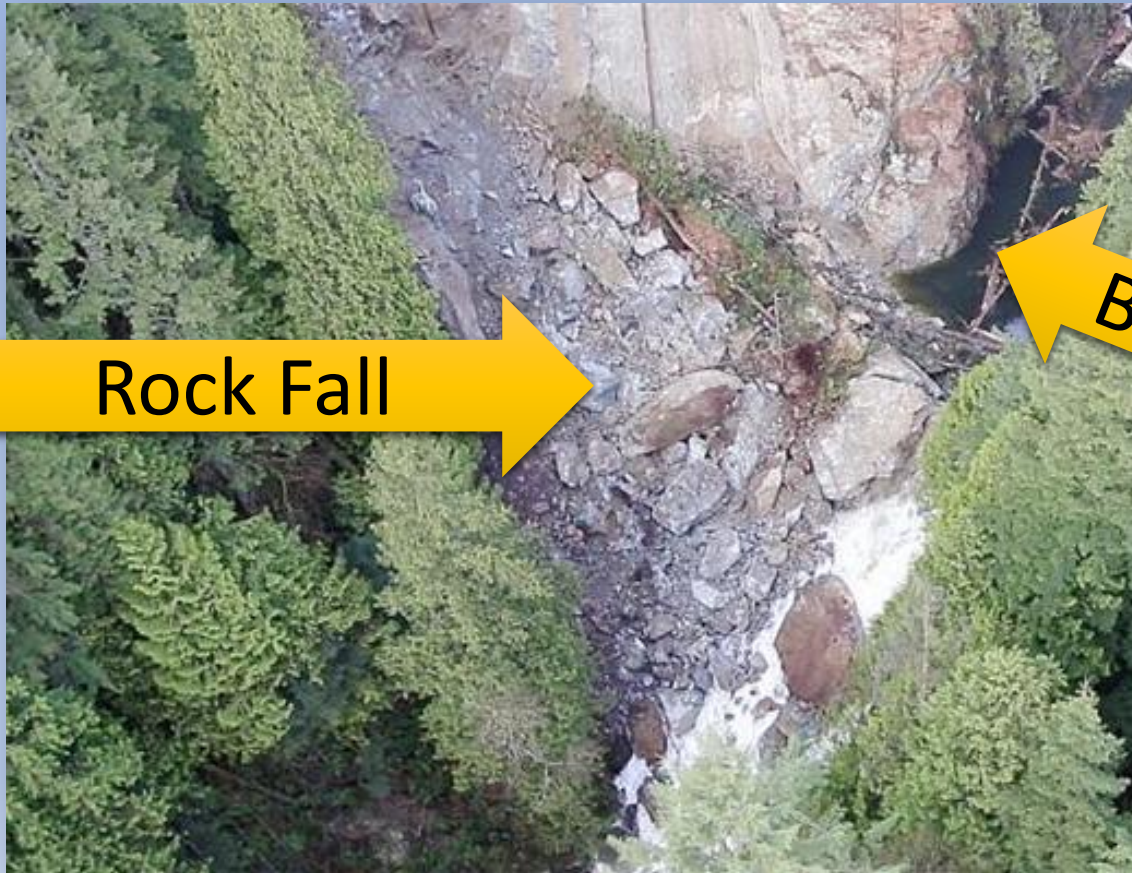
Seymour River Rock Fall Location

Upstream

Rock Fall

Backwater

Downstream

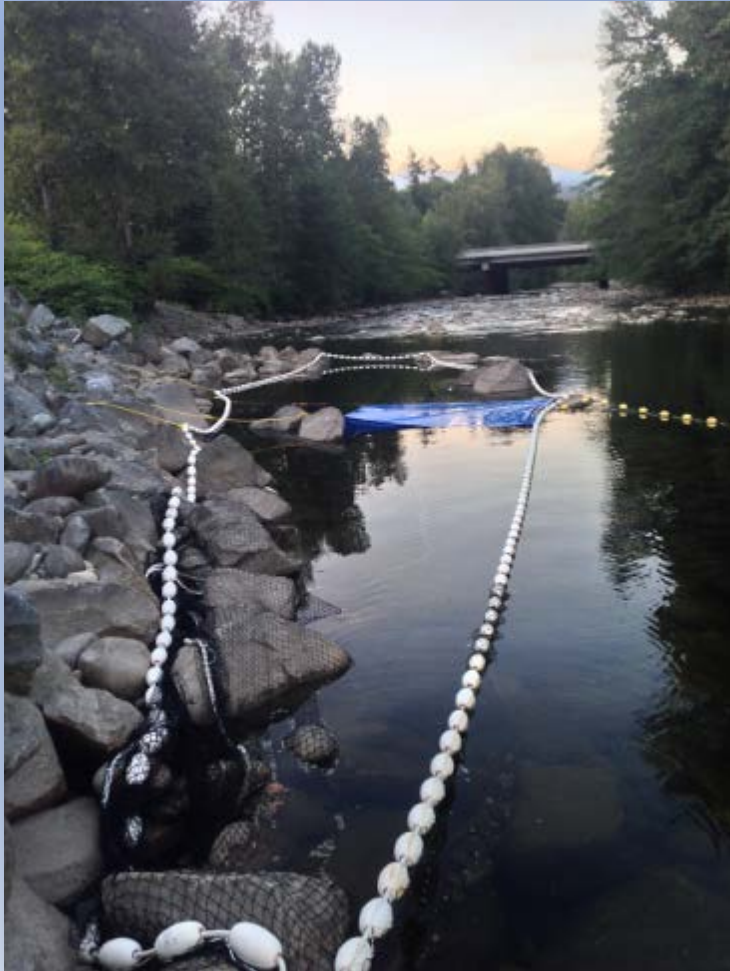
Lower River Project

Seymour Parkway Bridge

The capture system included a PVC trap within a large net anchored into the Seymour River immediately downstream of the Seymour Parkway Bridge.

PVC Trap

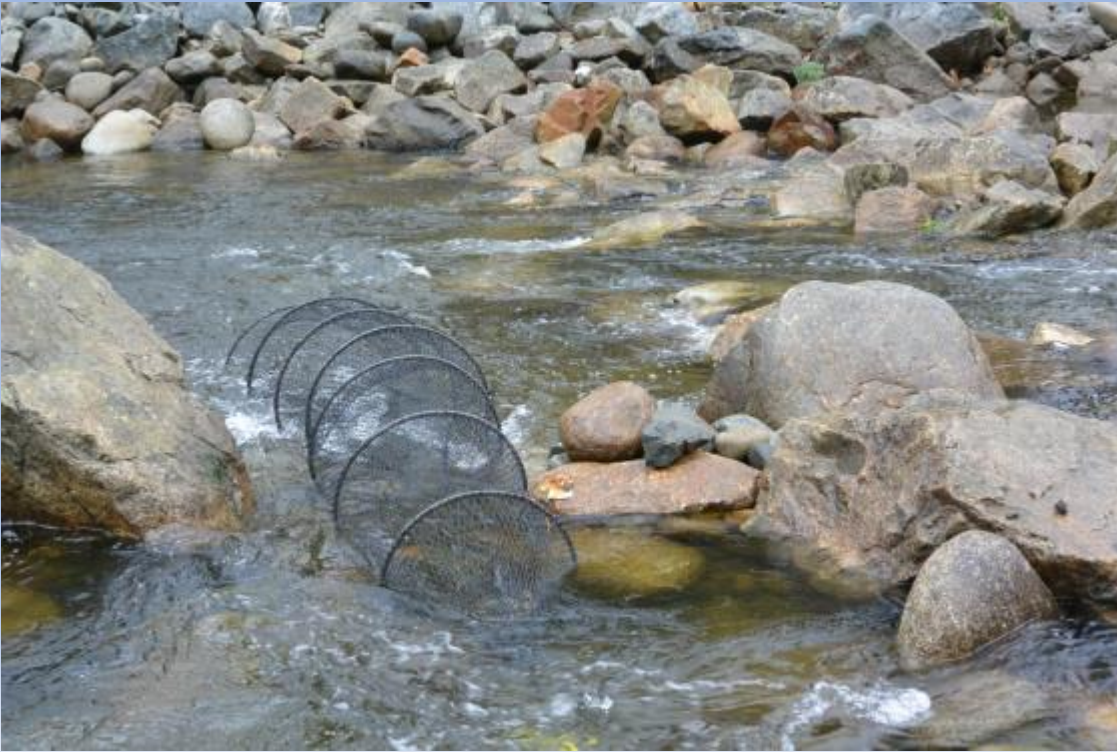
Hoop Net

The net trap has since been removed - hoop nets, tangle nets, seine nets and anglers are currently being used to capture fish in the Lower Seymour River

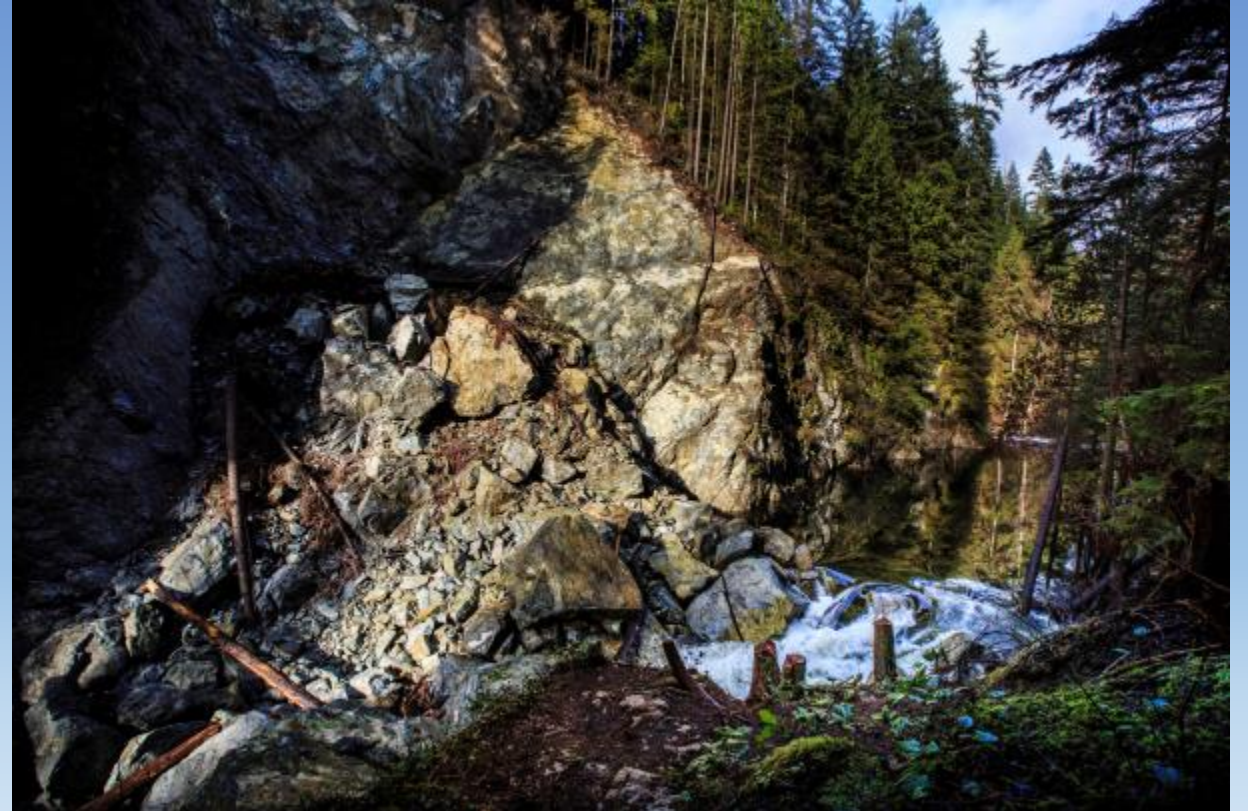
“Re-shaping the slide with scaling crews, low-velocity explosive rock-breaking and river flows”

- Non-conventional rock-breaking
- Limited heavy equipment
- River hydraulics to redistribute 10 000 – 20 000 m³ of material into a gradient that can be utilized by all salmon species

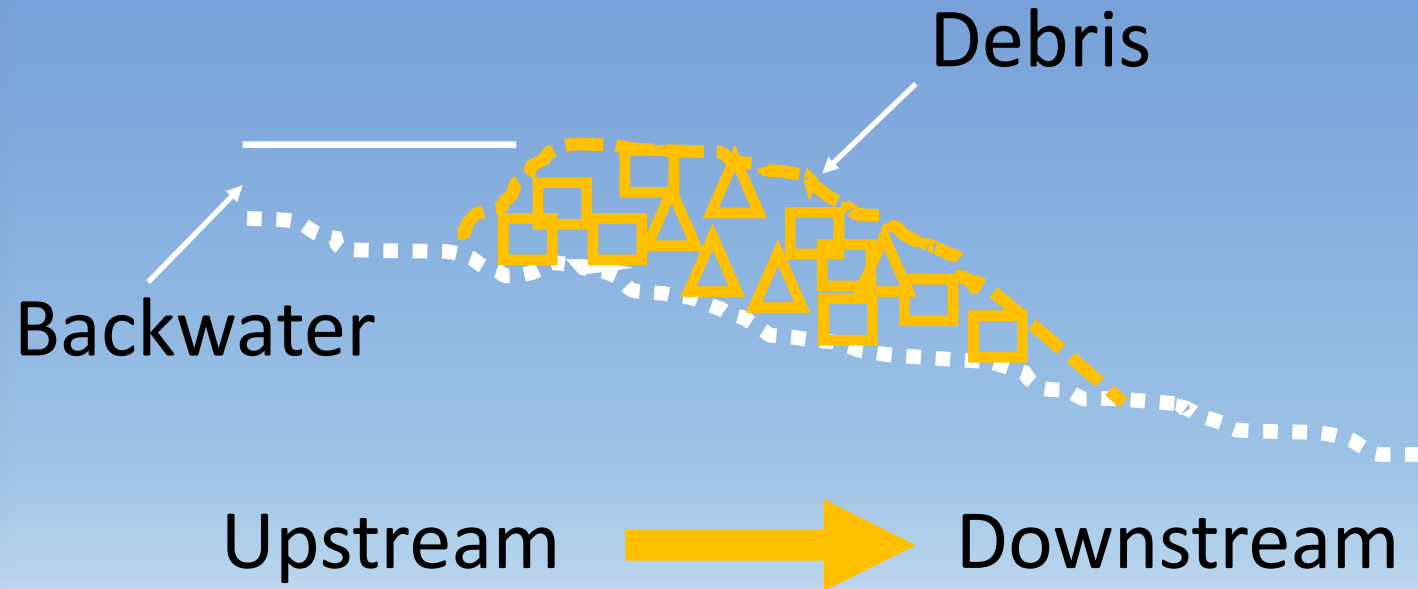
Schematic Cross-Section

Downstream

Goal to reduce debris pile grades –
steeper slopes to shallower slopes

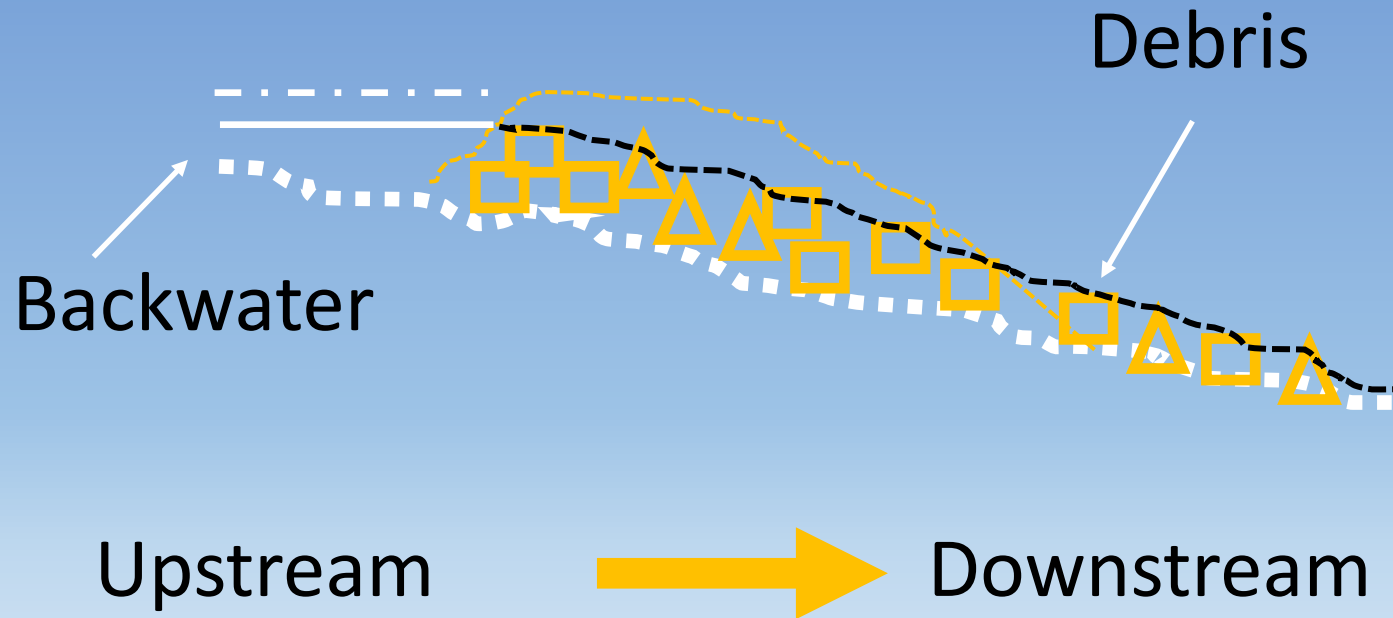
Schematic Cross-Section

Downstream

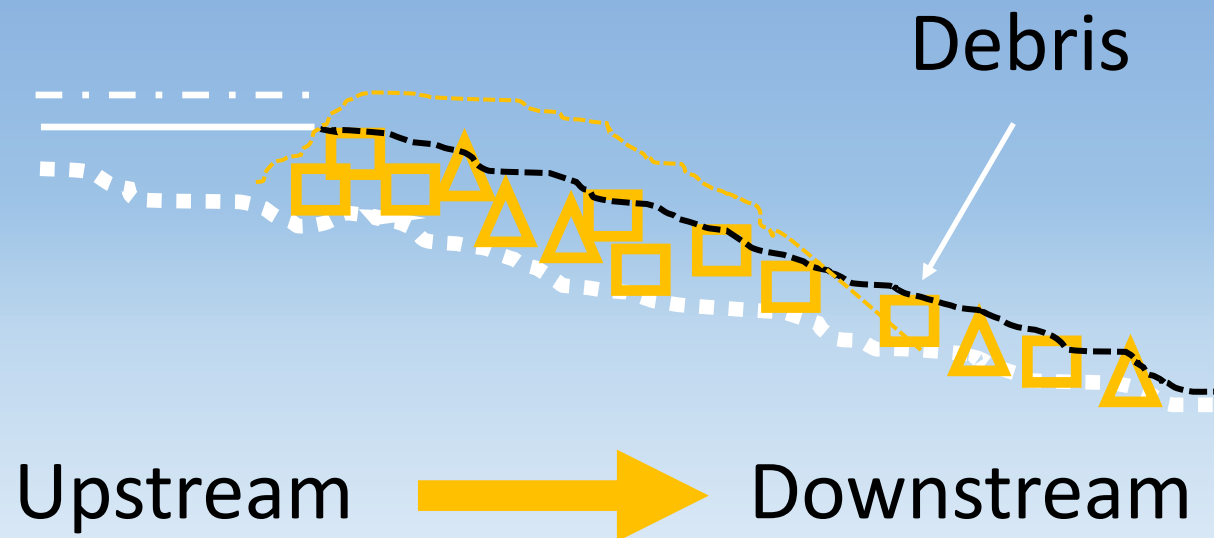
Work Flow

Escarpment crest to river channel
(top down for safety of site crew)

Upstream

Downstream

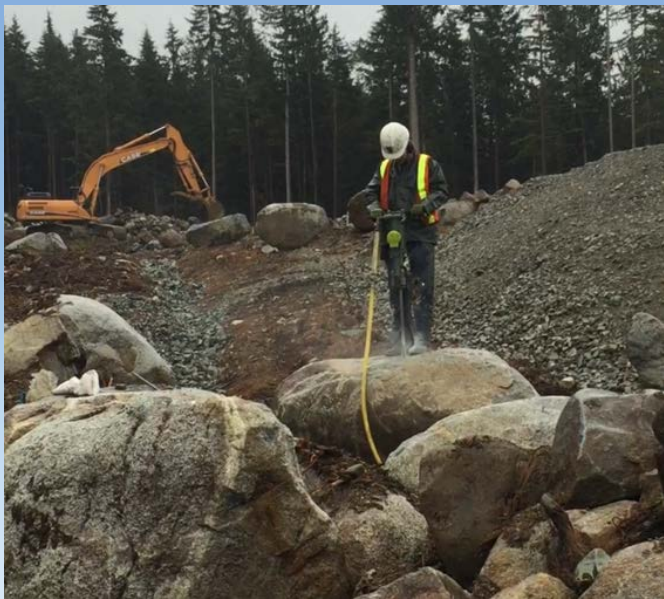
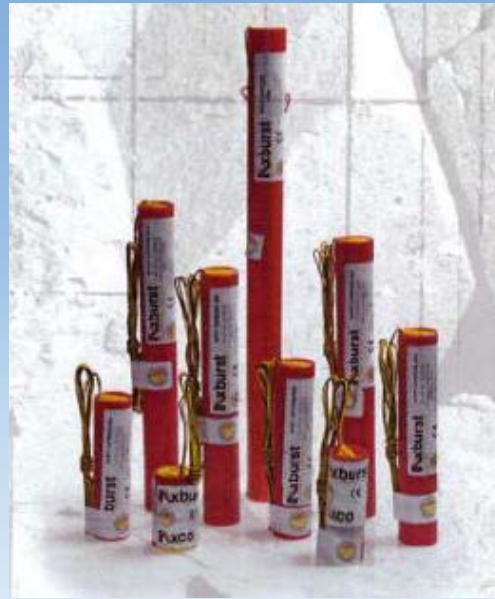
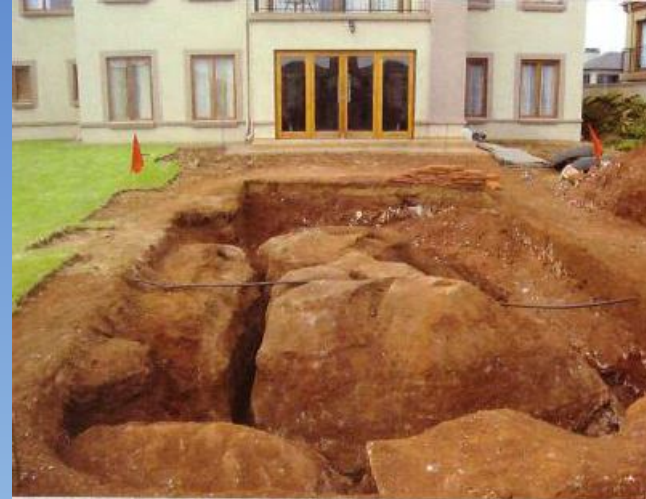
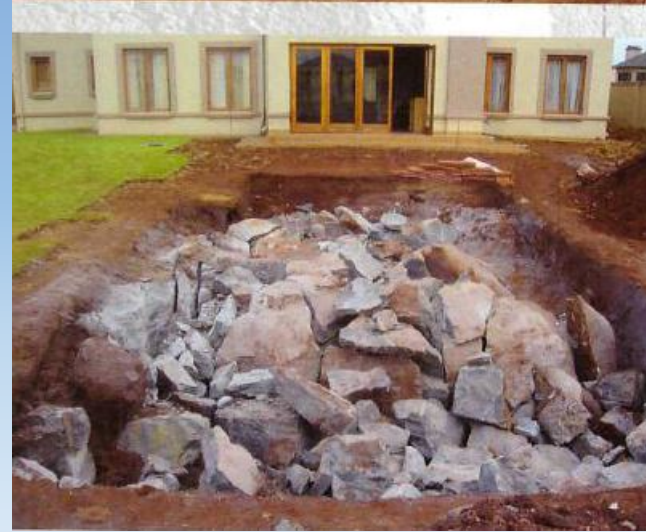
Construction Process

Drill

Low-Velocity Blast

Repeat
