## AGENDA ADDENDUM

SUBJECT: Neighbourhood Response to Development Variance Permit 61.21

Being Considered July 4, 2022 (3988 Phyllis Road)

#### Subject: Retaining wall inspection

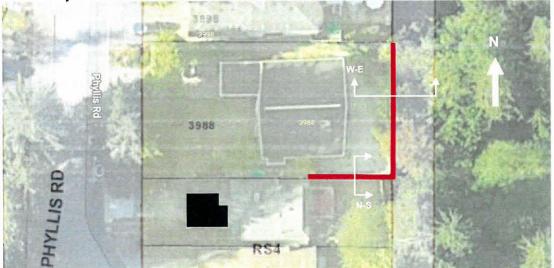
A retaining wall was recently built between the properties located at and 3988.
 Phyllis Rd as illustrated in red line below:

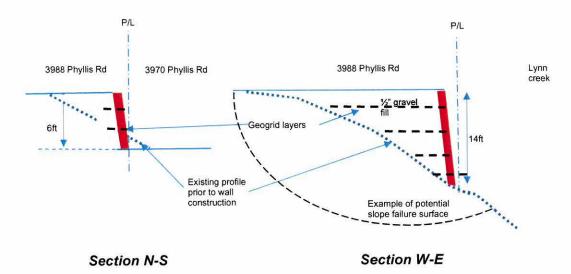
Following our discussions, the following sections are meant to provide a general understanding of the slope profiles along the sections indicated above. The sections are provided with estimated dimensions and are not at scale:

Note: the above sections may not be accurate as some of the gravel fill may have been replaced with soil.

No as-built drawing of the retaining wall were provided and is assumed to be built as per manufacturer's recommendations. However, it is understood that the wall was built without project's approved plan, which suggests that the length of the geogrid may not have been adequately verified by the necessary registered professional.
